# Inspection Report

## Kyle's Home Inspections

### Property Address

1111 Sample Rd Drive Winchester, CA, 92596

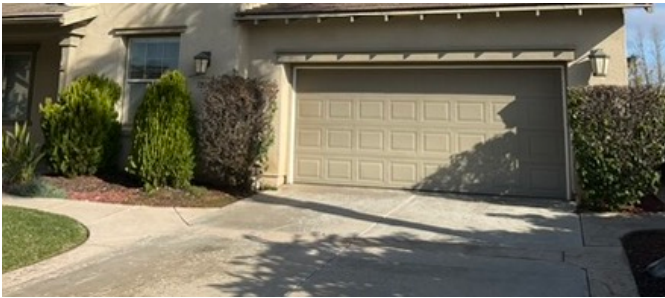
**1.2) Driveway Conditions**

The driveway appeared to be in serviceable condition at the time of the inspection.

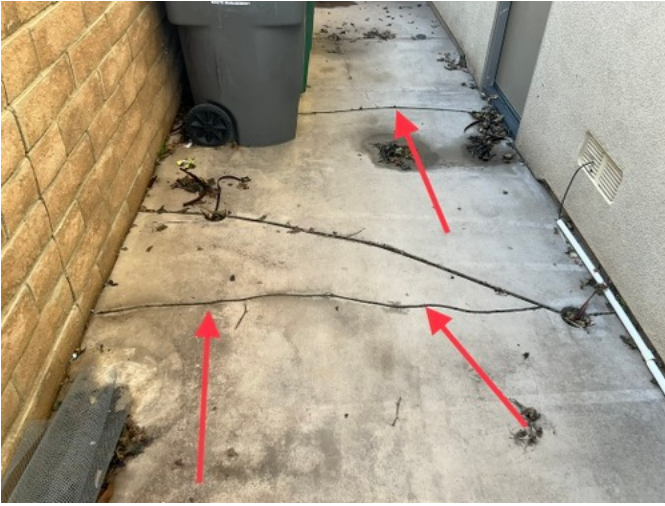
**1.3) Sidewalk Conditions**

The visible areas of the sidewalk appeared to be in serviceable condition at the time of the inspection. Common cracks of up to  $\frac{1}{4}$  inch were observed.

The visible areas of the sidewalk appeared to be in serviceable condition at the time of the inspection. Common cracks of up to ¼ inch were observed.

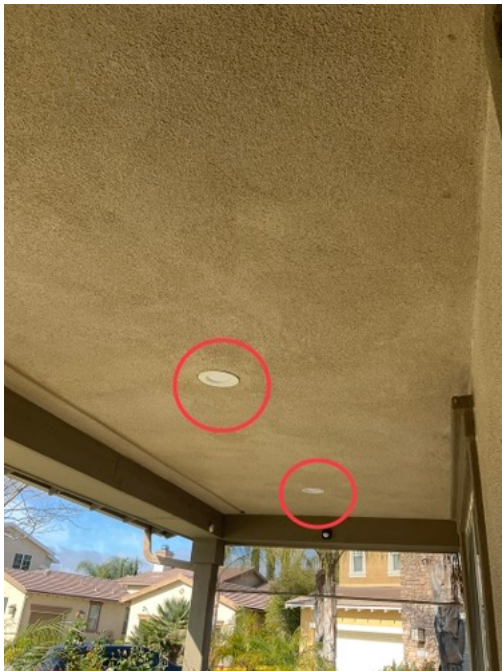
#### 2.1) Front Entrance Conditions

Front porch recessed lights not operable at time of inspection. It is suggested that a "Licensed Electrical Contractor" be contacted for further evaluation and repair.

Front porch recessed lights not operable at time of inspection. It is suggested that a "Licensed Electrical Contractor" be contacted for further evaluation and repair.

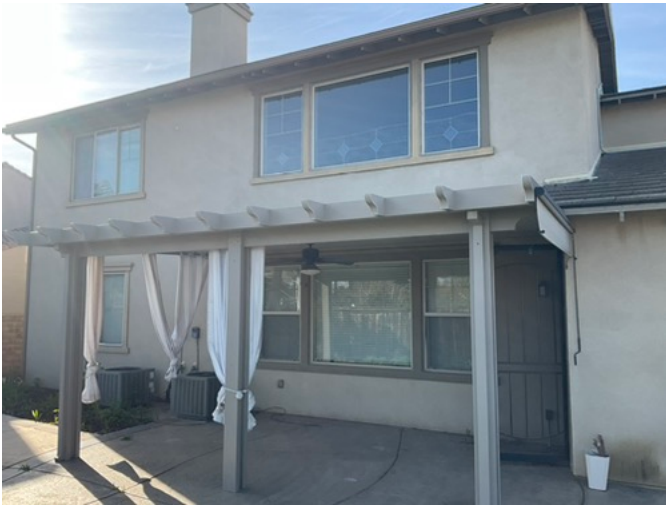
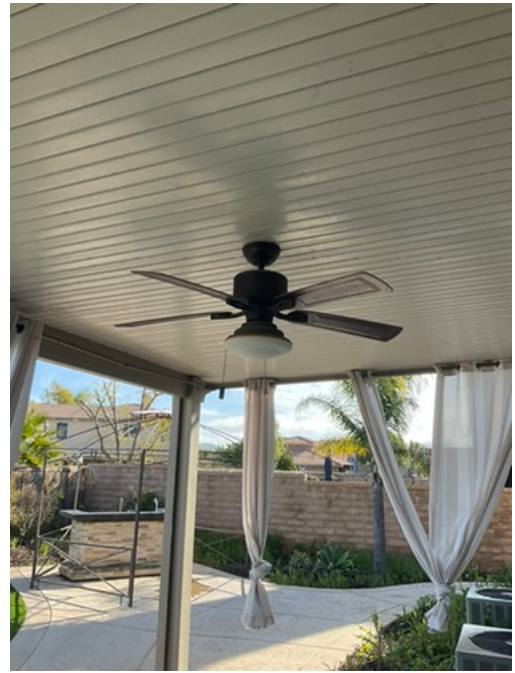
#### 2.2) Back Entrance Conditions

The visible portions of the patio appeared to be in serviceable condition at the time of the inspection.

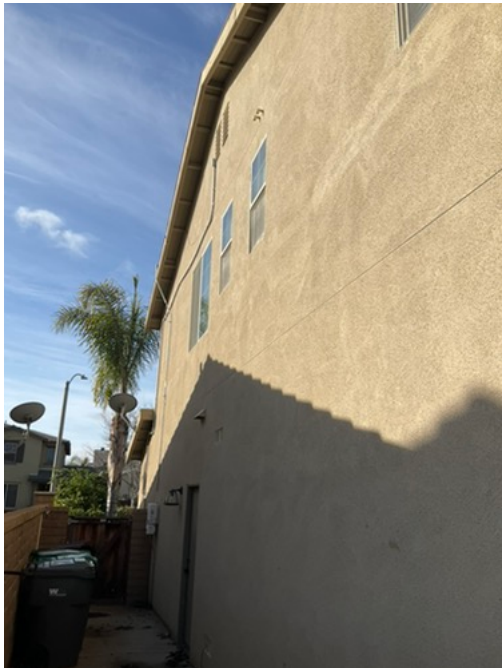
### **2.3) Exterior Wall Conditions**

The visible and accessible areas of the exterior siding material are stucco.

The visible and accessible portions of the exterior wall coverings appeared to be in serviceable condition at the time of the inspection. Common cracks were found in the exterior walls.

The visible and accessible portions of the exterior wall coverings appeared to be in serviceable condition at the time of the inspection. Common cracks were found in the exterior walls. Recommend sealing to reduce the possibility of water penetration.

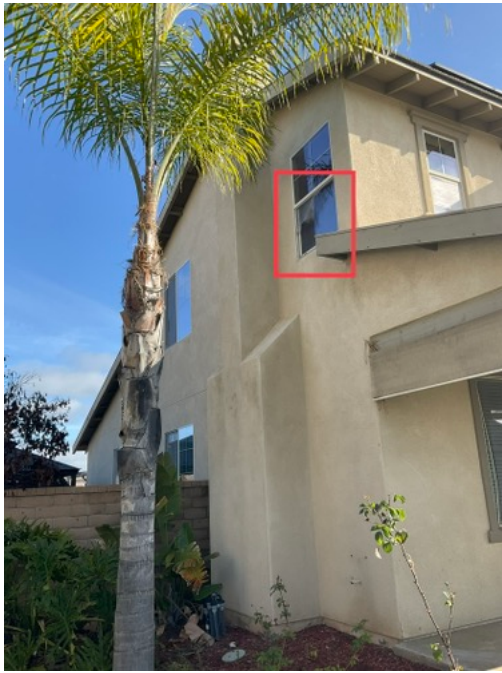
**2.4) Window Conditions**

2nd story window on the west side of the home had a damaged window screen.It is suggested that a "Licensed General Contractor" be contacted for further evaluation and repair.

2nd story window on the west side of the home had a damaged window screen. It is suggested that a "Licensed General Contractor" be contacted for further evaluation and repair.

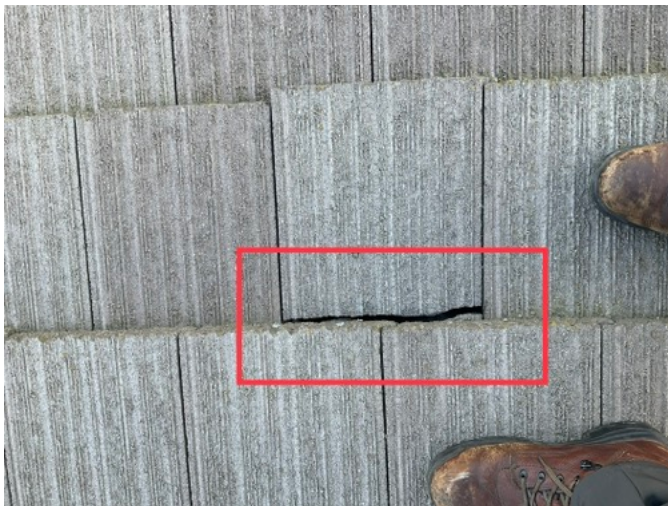
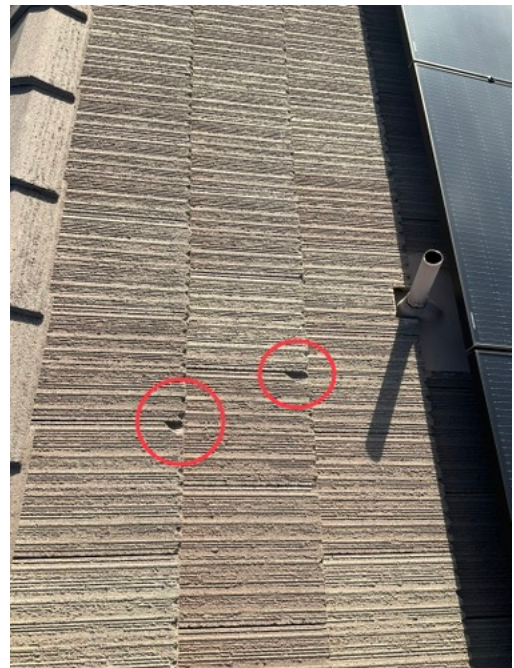
**3.1) Roof Covering Condition**

Damaged or missing shingles were observed at . Recommend further evaluation and repair as needed by a qualified / licensed contractor. The inspector can not offer an opinion as to whether the roof leaks today unless it is moderately raining at the time of inspection. Client should obtain full disclosure / history information from the seller prior to close.

Damaged or missing shingles were observed at . Recommend further evaluation and repair as needed by a qualified / licensed contractor. The inspector can not offer an opinion as to whether the roof leaks today unless it is moderately raining at the time of inspection. Client should obtain full disclosure / history information from the seller prior to close.

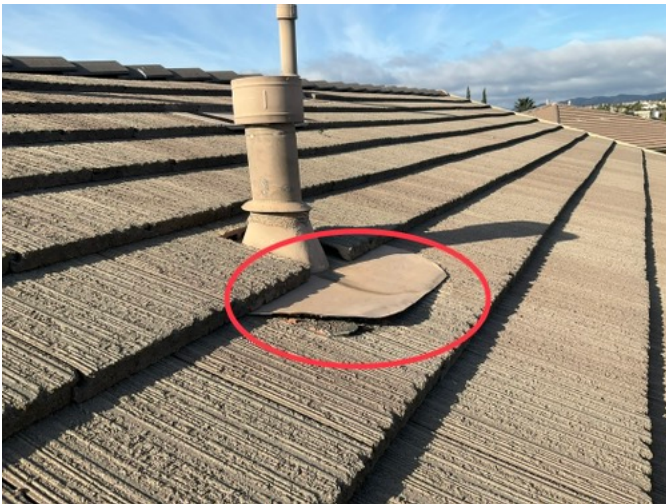
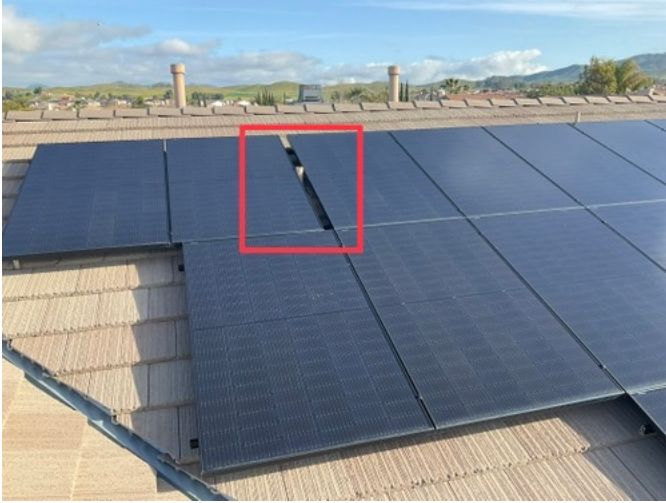
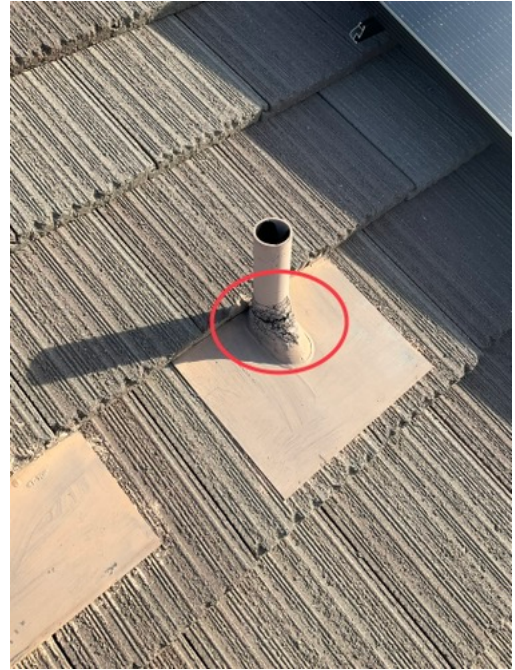
### 3.2) Flashing Conditions

Sealing is needed at all vent pipes, chimney, wall and valley seams, and any other through roof projections (including skylights if present) to reduce the possibility of water penetration.

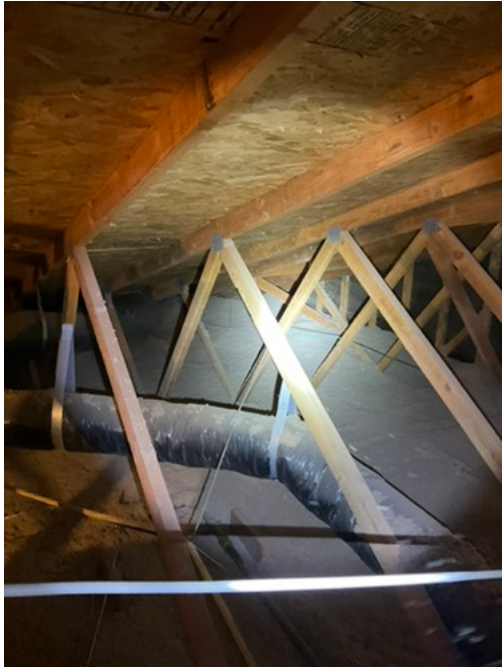
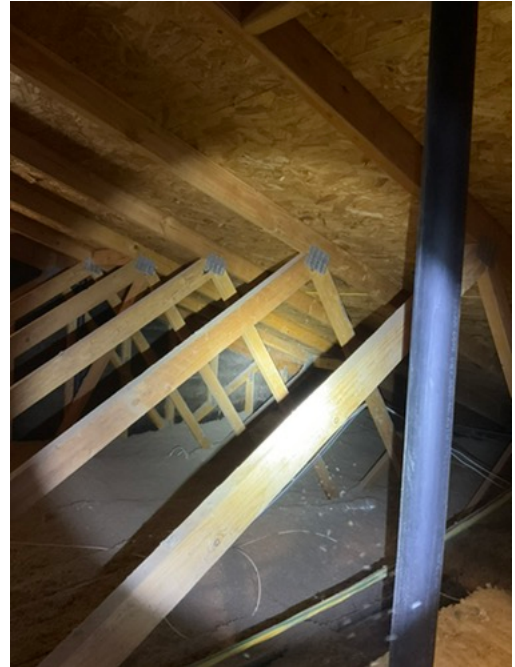
**3.4) Attic Conditions**

The visible and accessible portions of the attic appeared to be in serviceable condition at the time of the inspection.

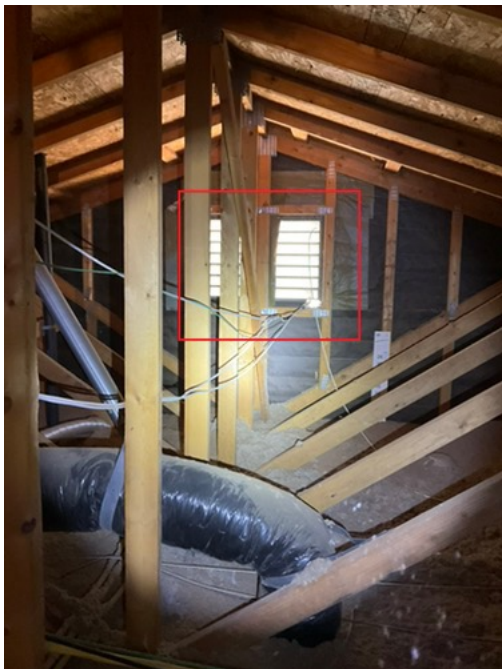
**3.5) Attic Ventilation Conditions**

The ventilation screens or gable vents were ripped or damaged and should be repaired or replaced. There was wiring ran out of the vent and the screen was cut to do so.

The ventilation screens or gable vents were ripped or damaged and should be repaired or replaced. There was wiring ran out of the vent and the screen was cut to do so.

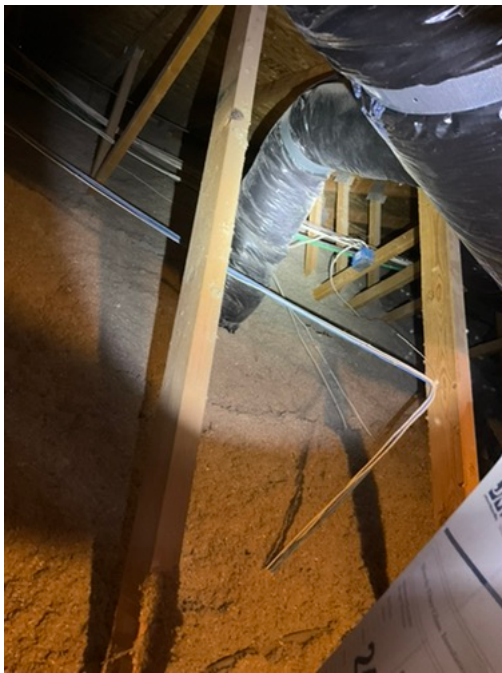
**3.6) Attic Insulation Conditions**

Loose fill.

The attic has minimal amount blown-in insulation. The approximate depth of the insulation is 6 inches. Additional insulation should be considered.

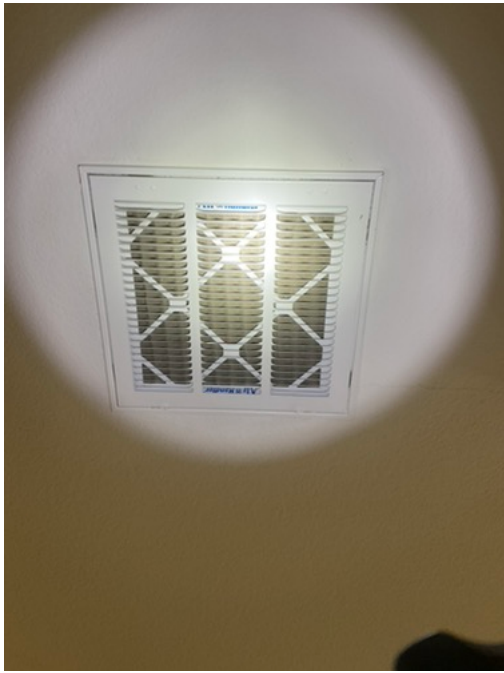
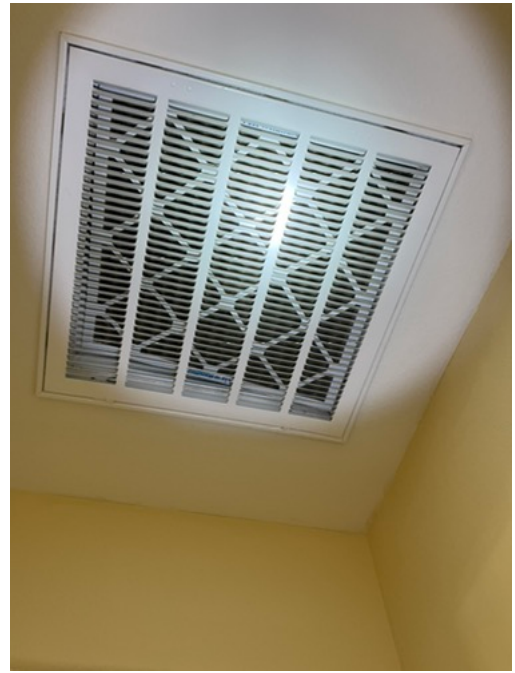
**4.1) Unit Conditions**

The heating system was operational at time of inspection. This is not an indication of future operation or condition. The air filter was dirty. Suggest replacing as soon as possible. To increase the efficiency of your heating system, we recommend changing your systems fir filter(s) regularly ( every 2-3 months ).

The heating system was operational at time of inspection. This is not an indication of future operation or condition. The air filter was dirty. Suggest replacing as soon as possible. To increase the efficiency of your heating system, we recommend changing your systems fir filter(s) regularly ( every 2-3 months ).

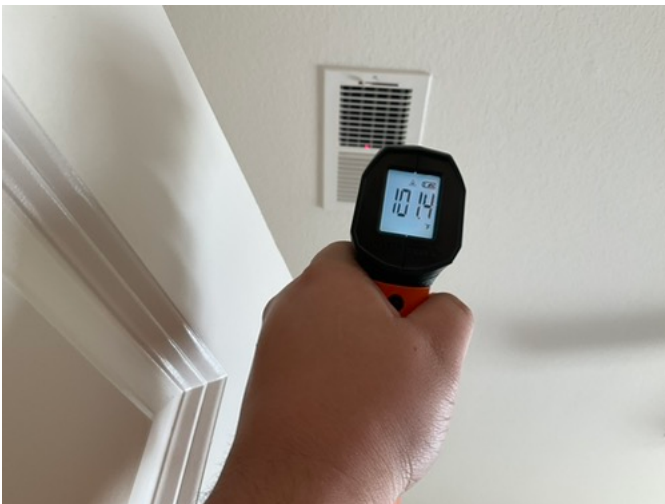
**4.2) Distribution Conditions**

The visible and accessible areas of the distribution system appeared to be in serviceable condition at the time of inspection. Temps read at 101.4

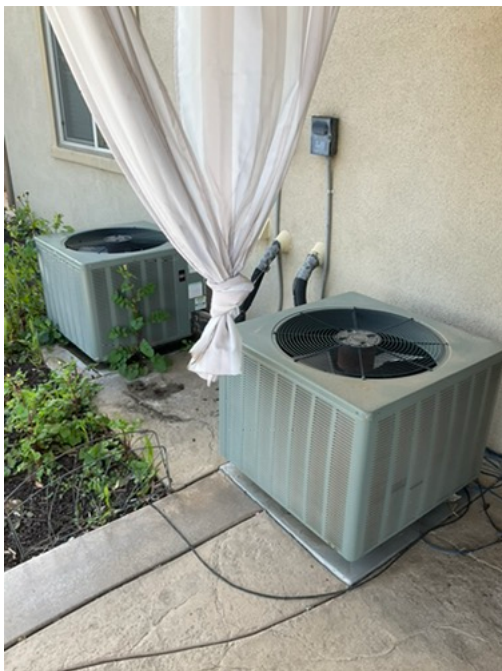
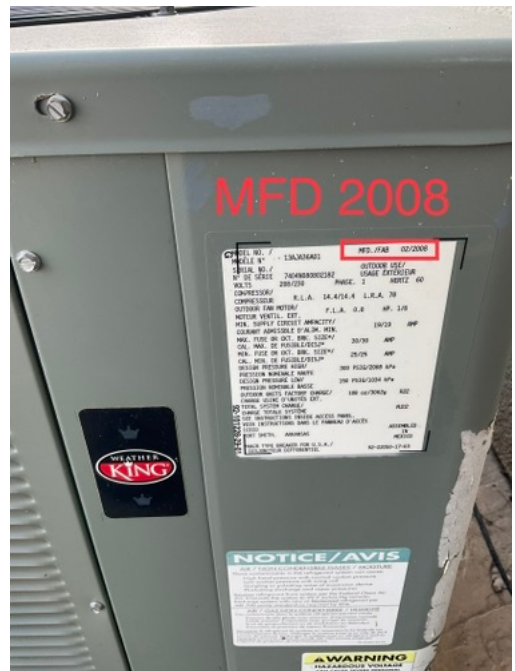
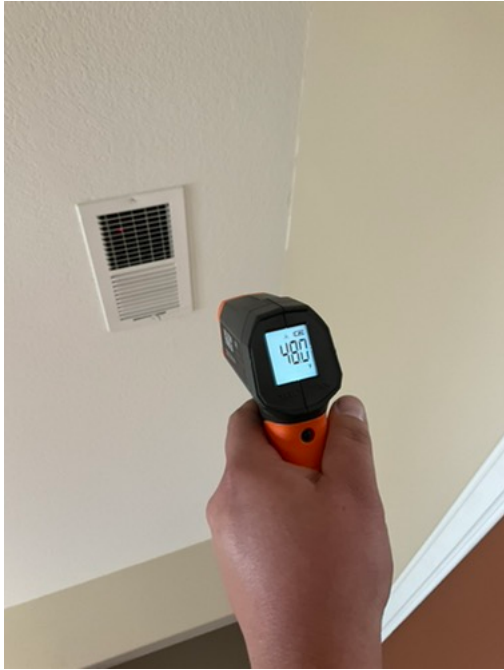
**4.5) AC Unit Conditions**

It was observed that the condenser coil was dirty and in need of cleaning and service.  
Manufactured 2008. Temps read at 48

It was observed that the condenser coil was dirty and in need of cleaning and service. Manufactured 2008. Temps read at 48

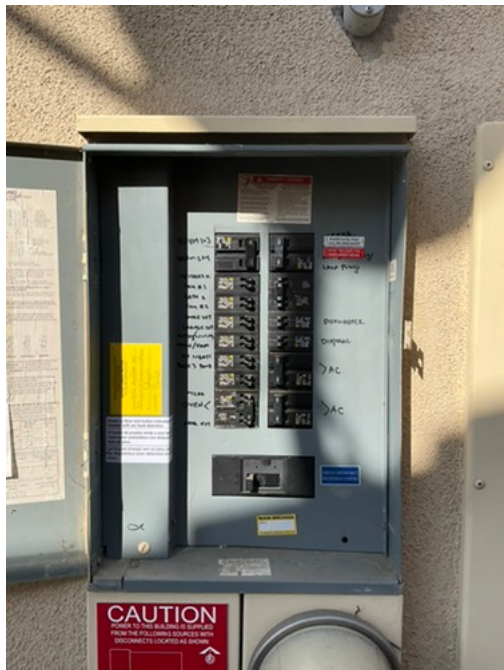
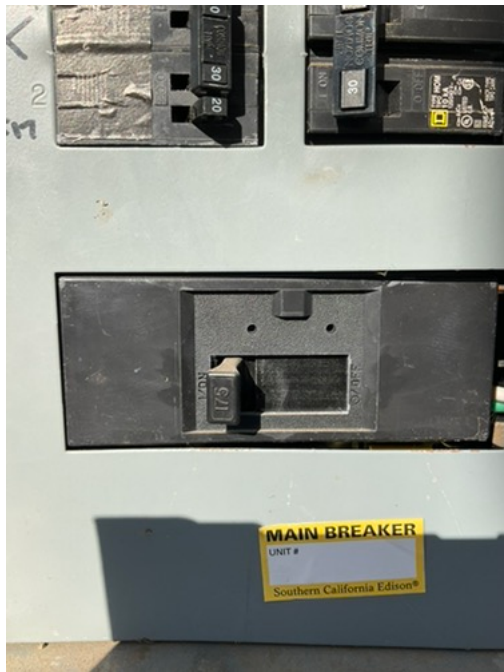
**Main Electrical Panel**

<b>Main Disconnect Location</b>	At Main Panel.
<b>Electric Panel Location</b>	The main electric panel is located at the exterior.

<b>Panel Amperage Rating</b>	The electrical capacity of main breaker was listed / labeled as 175 amps.
------------------------------	---

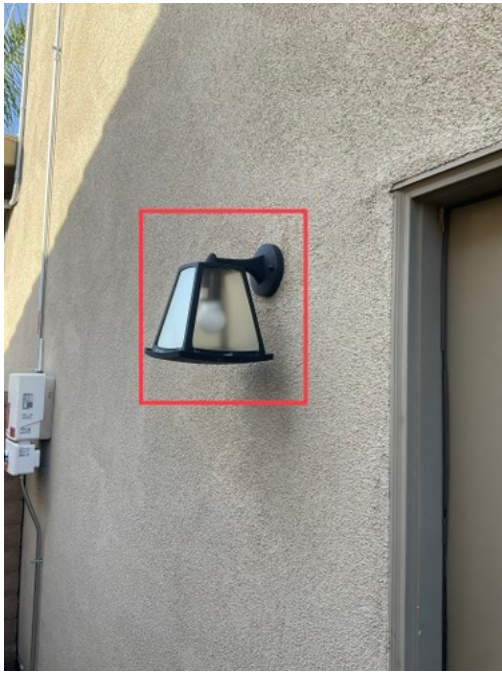
### 5.4) Electrical Fixtures Conditions

Light fixtures are upside down. Installed incorrectly. It is suggested that a "Licensed Electrical Contractor" be contacted for further evaluation and repair.

Light fixtures are upside down. Installed incorrectly. It is suggested that a "Licensed Electrical Contractor" be contacted for further evaluation and repair.

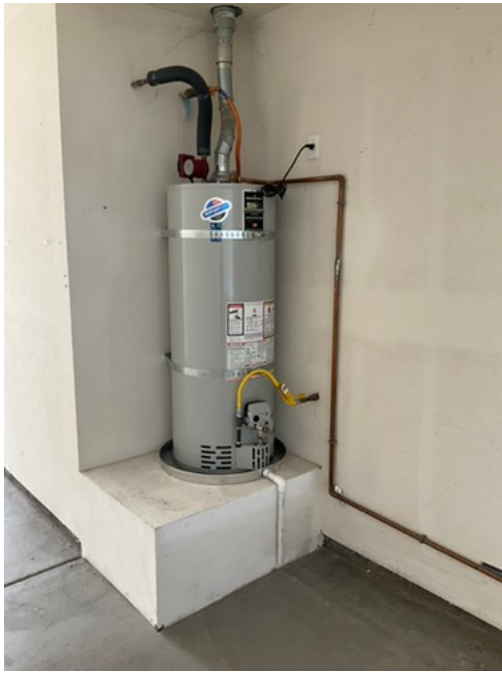
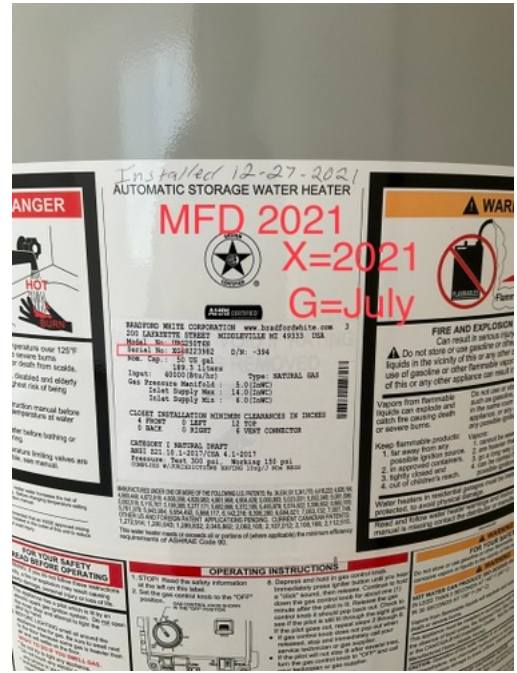
**Water Heater Location**

Garage. Manufactured 2021

**Water Heater Capacity** 50 Gallon.

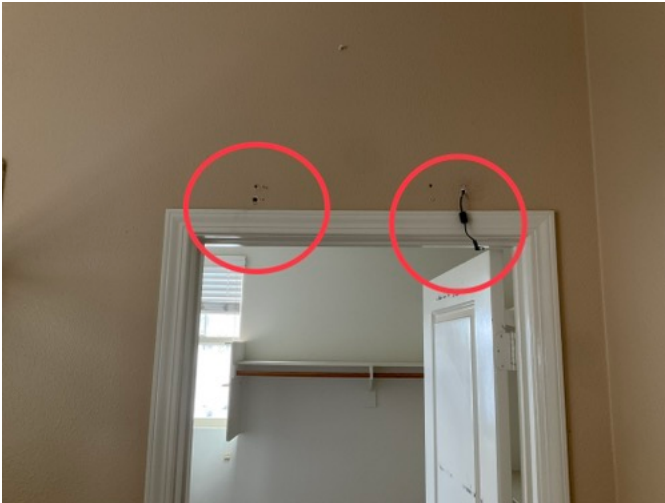
#### 7.1) Wall Conditions

The interior walls had small holes throughout home. Recommend maintenance as needed.

The interior walls had small holes throughout home. Recommend maintenance as needed.

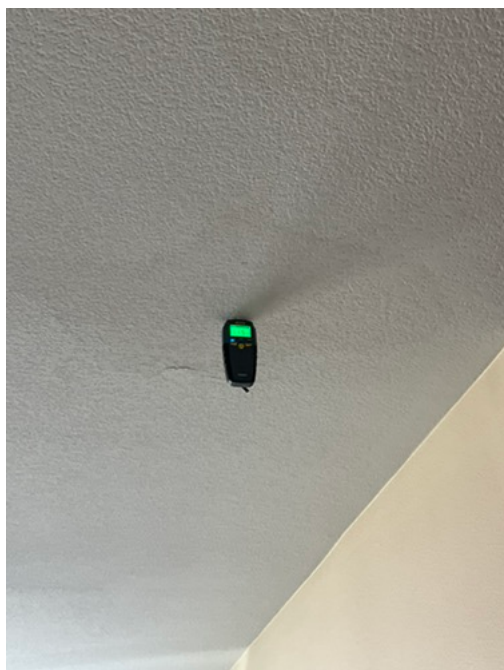
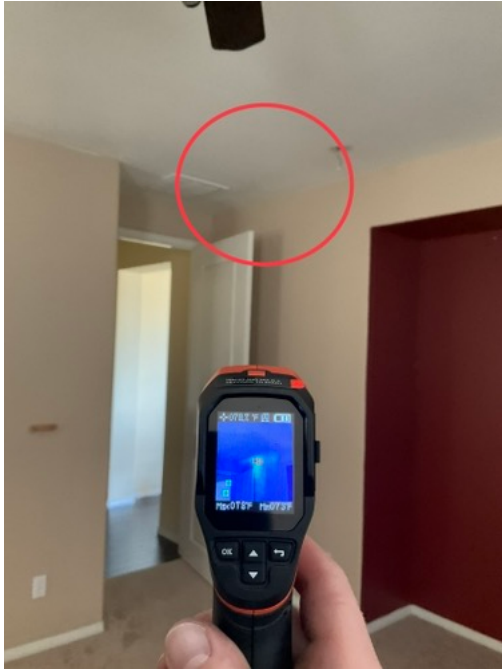
#### 7.2) Ceiling Conditions

Moisture damage was observed at main living area. Hidden damage may exist in areas not readily visible or accessible. Moisture read at 11.5%. It is suggested that a "Licensed Roofing Contractor" be contacted for further evaluation and repair. Thermal gun picked up moisture in the area of the leak on the adjacent wall facing it.

Moisture damage was observed at main living area. Hidden damage may exist in areas not readily visible or accessible. Moisture read at 11.5% It is suggested that a "Licensed Roofing Contractor" be contacted for further evaluation and repair. Thermal gun picked up moisture in the area of the leak on the adjacent wall facing it.

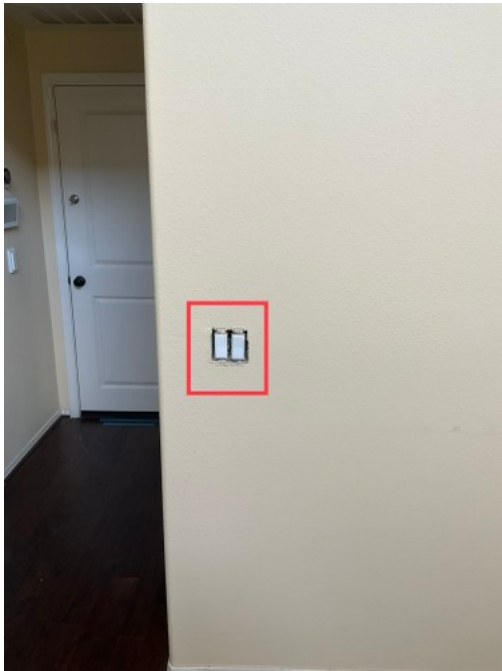
#### 7.7) Electrical Conditions

Missing receptacle or switch covers were observed at living room. Recommend covers be

Missing receptacle or switch covers were observed at living room. Recommend covers be installed for safety.

installed for safety.

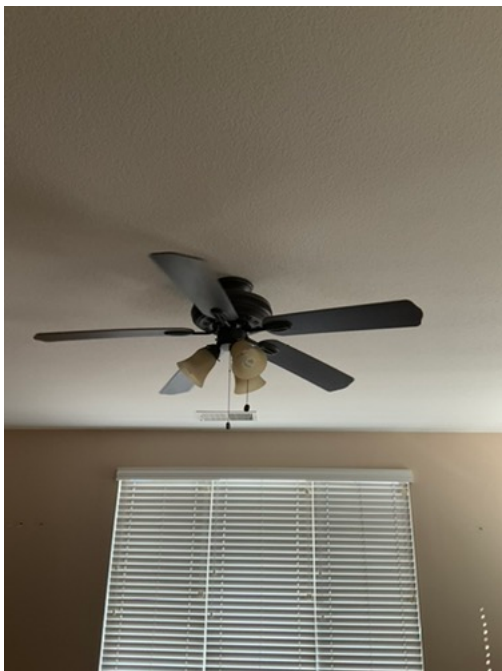
### 7.9) Ceiling Fan Conditions

The ceiling fan(s) was not operational at 2nd floor master bedroom. Recommend further evaluation and repair as needed by a qualified / licensed contractor.

The ceiling fan(s) was not operational at 2nd floor master bedroom. Recommend further evaluation and repair as needed by a qualified / licensed contractor.

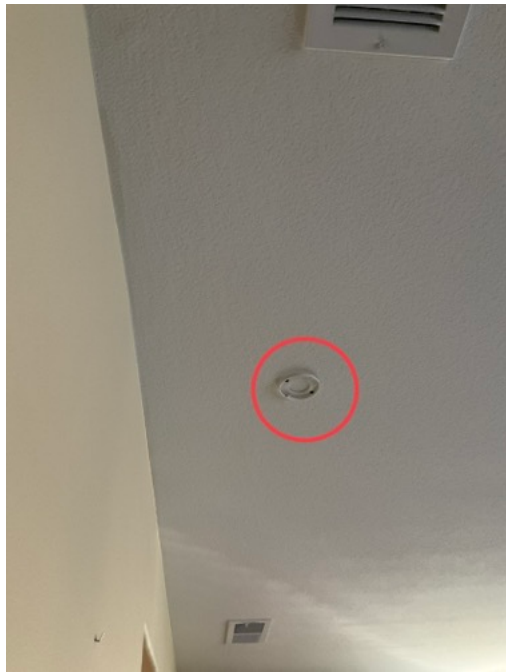
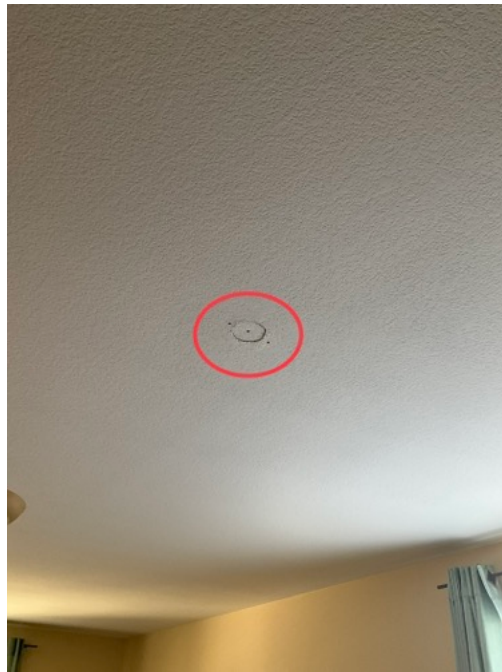
**7.10) Smoke Detector Conditions**

No smoke detectors were found at the time of the inspection. Recommend smoke detectors on each level and near or in each bedroom. Client should contact the local Fire o Marshall's office for proper locations.

No smoke detectors were found at the time of the inspection. Recommend smoke detectors on each level and near or in each bedroom. Client should contact the local Fire o Marshall's office for proper locations.

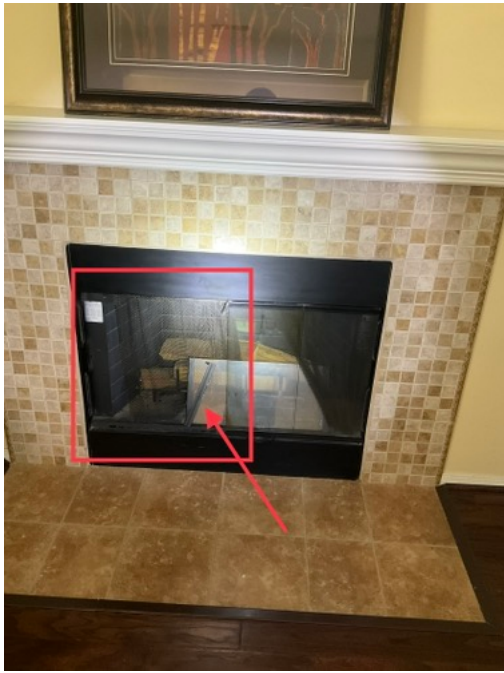
**7.11) Fireplace Conditions**

Glass door was off hinge and debris inside the fireplace. It is recommended to hire a licensed chimney sweeper to clean and maintenance the chimney before use.

Glass door was off hinge and debris inside the fireplace. It is recommended to hire a licensed chimney sweeper to clean and maintenance the chimney before use.

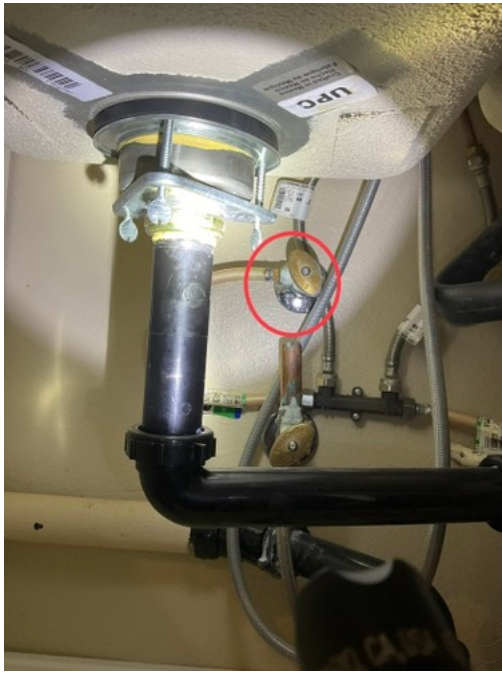
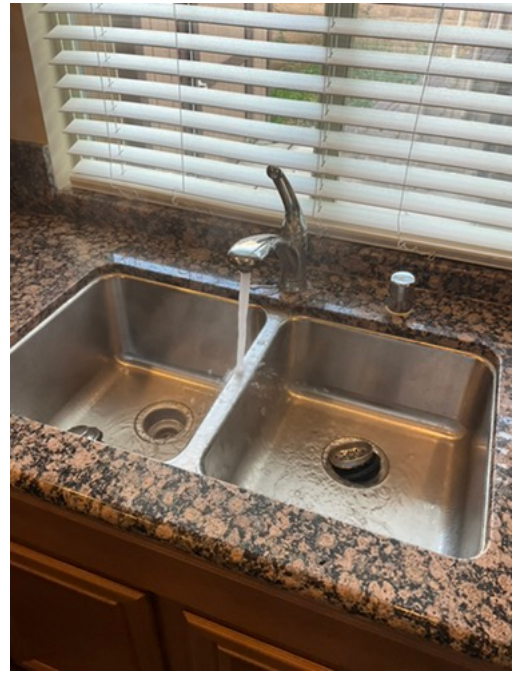
### 8.12) Sink Plumbing Conditions

The pipes under the sink had evidence of rust with some corrosion noted. The hot water was also shut off at faucet. It is suggested that a "Licensed Plumbing Contractor" be contacted for further evaluation and repair.

The pipes under the sink had evidence of rust with some corrosion noted. The hot water was also shut off at faucet. It is suggested that a "Licensed Plumbing Contractor" be contacted for further evaluation and repair.

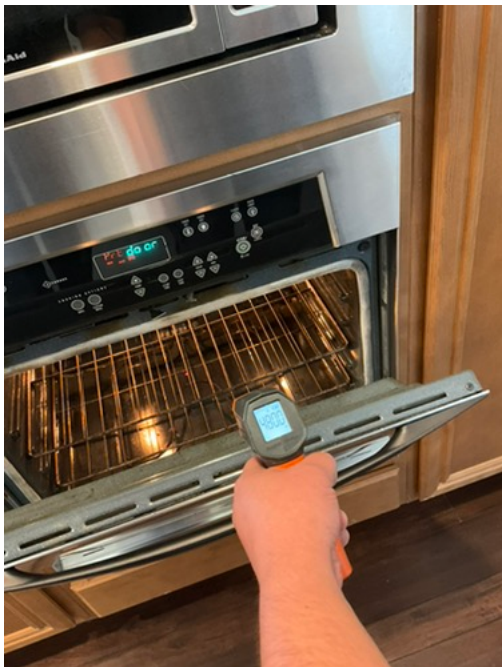
**8.14) Stove - Range Condition**

The oven is gas. Temps read at 480

The oven was in operational condition at the time of the inspection. This does not however guarantee future conditions after the time of inspection.

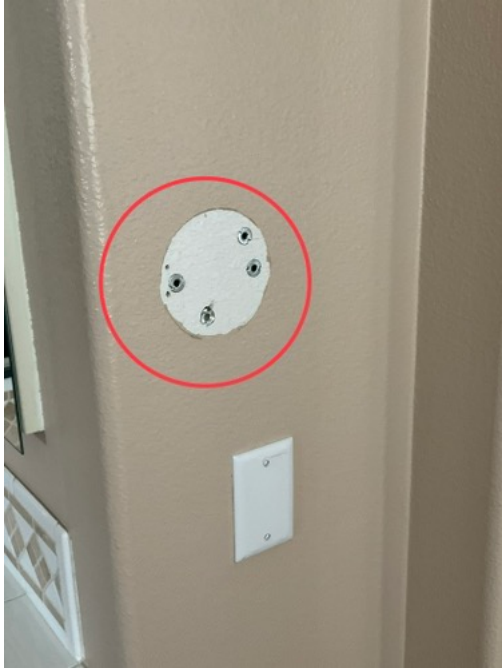
The walls had small holes. Recommend maintenance as needed.

The walls had small holes. Recommend maintenance as needed.

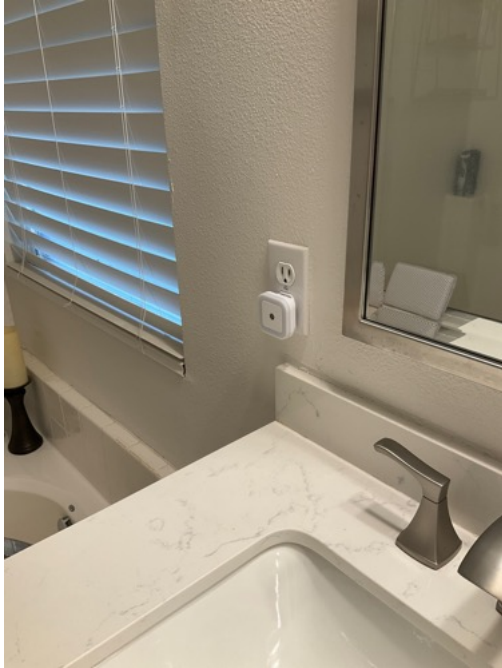
#### 9.7) Electrical Conditions

GFIC (Ground Fault Interrupter Circuit) receptacle circuit (a safety device for outlets near water) recommended It is suggested that a "Licensed Electrical Contractor" be contacted for further evaluation and repair.

GFIC (Ground Fault Interrupter Circuit) receptacle circuit (a safety device for outlets near water) recommended It is suggested that a "Licensed Electrical Contractor" be contacted for further evaluation and repair.

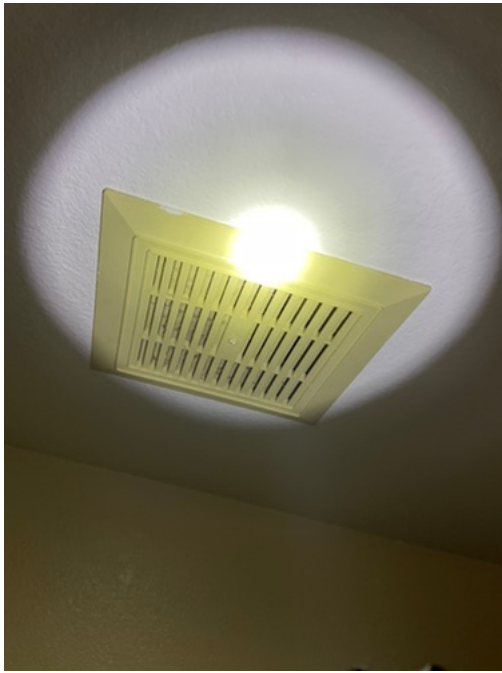
#### 9.9) Vent Fan Conditions

The exhaust fan made an unusual noise / vibration in bath. Recommend maintenance as needed. Recommend repairs as needed.

The exhaust fan made an unusual noise / vibration in bath. Recommend maintenance as needed. Recommend repairs as needed.

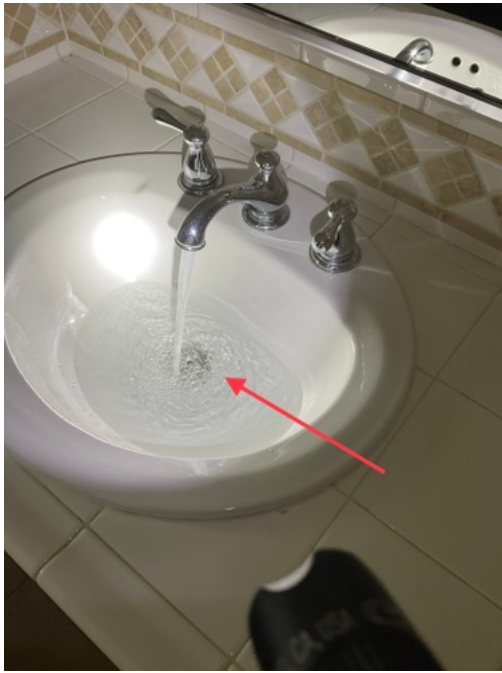
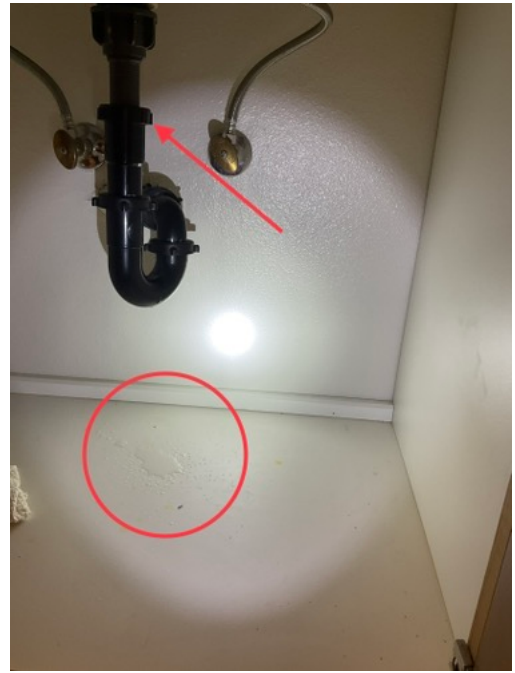
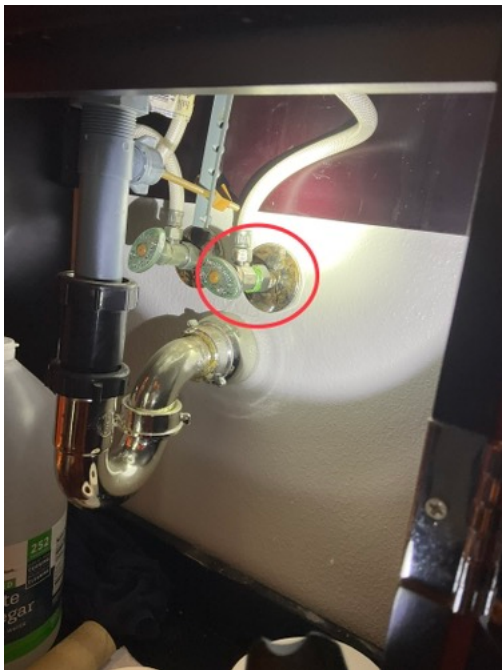
### **9.11) Sink Conditions**

The sink drained slowly at the time of inspection in bath . Repair may be warranted. The drain pipe was leaking in bath. There was corrosion and / or damage at the sink faucet in bath . Recommend repair. It is suggested that a "Licensed Plumbing Contractor" be contacted for further evaluation and repair.

The sink drained slowly at the time of inspection in bath . Repair may be warranted. The drain pipe was leaking in bath. There was corrosion and / or damage at the sink faucet in bath . Recommend repair. It is suggested that a "Licensed Plumbing Contractor" be contacted for further evaluation and repair.

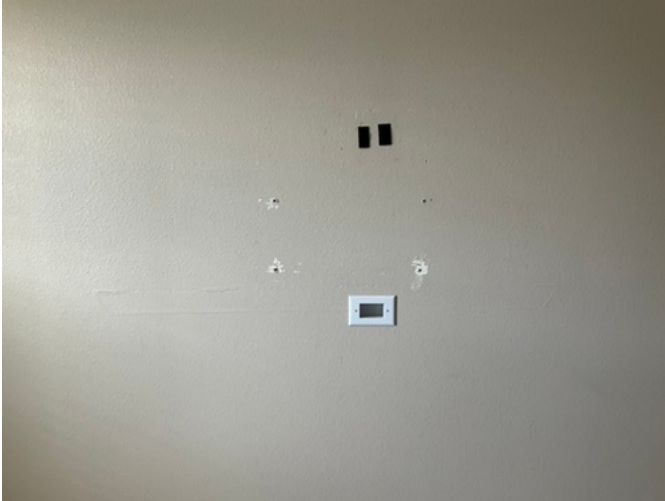
The walls had small holes. Recommend maintenance as needed.

The walls had small holes. Recommend maintenance as needed.

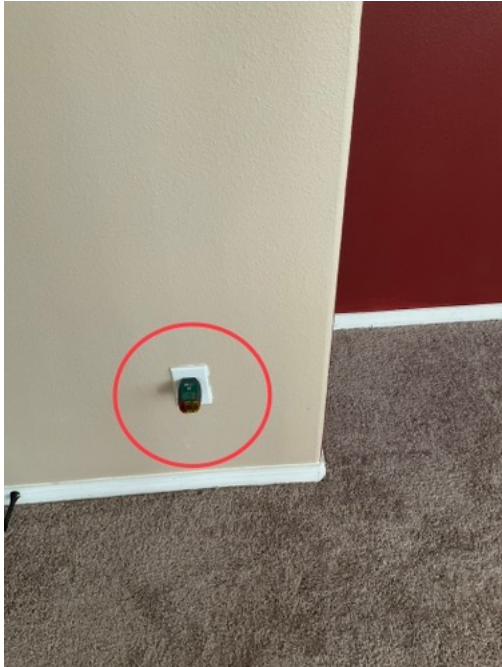
**10.7) Electrical Conditions**

Multiple bedroom outlets had no power to them. It is suggested that a "Licensed Electrical Contractor" be contacted for further evaluation and repair.

Multiple bedroom outlets had no power to them. It is suggested that a "Licensed Electrical Contractor" be contacted for further evaluation and repair.

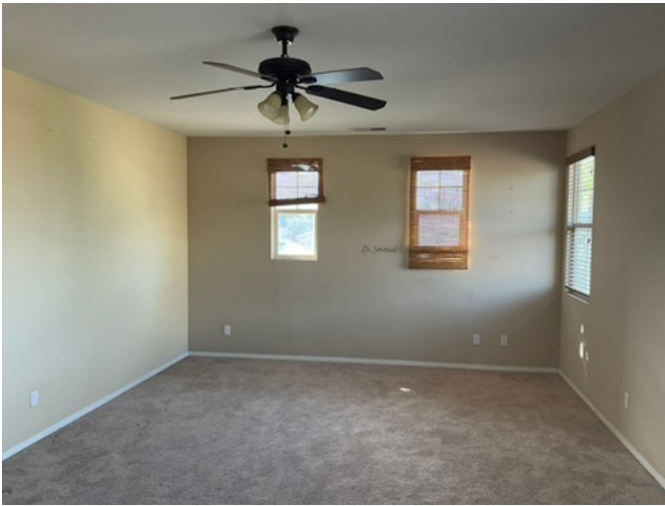
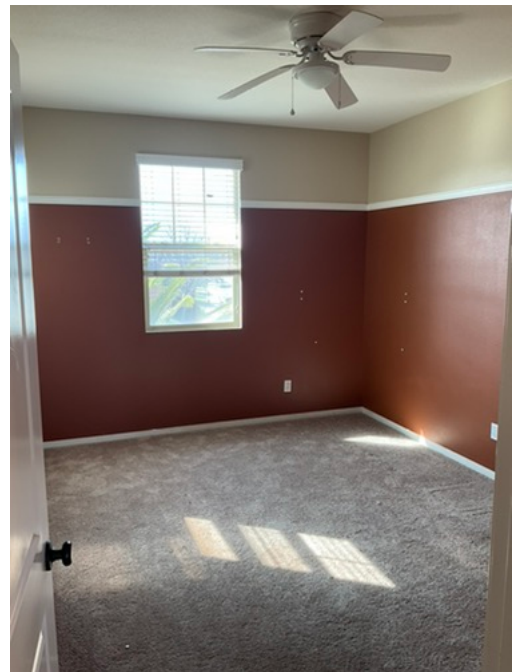
**10.10) Smoke Detectors Conditions**

No smoke detectors were found at the time of the inspection. Recommend smoke detectors on each level and near or in each bedroom. Client should contact the local Fire o Marshall's office for proper locations.

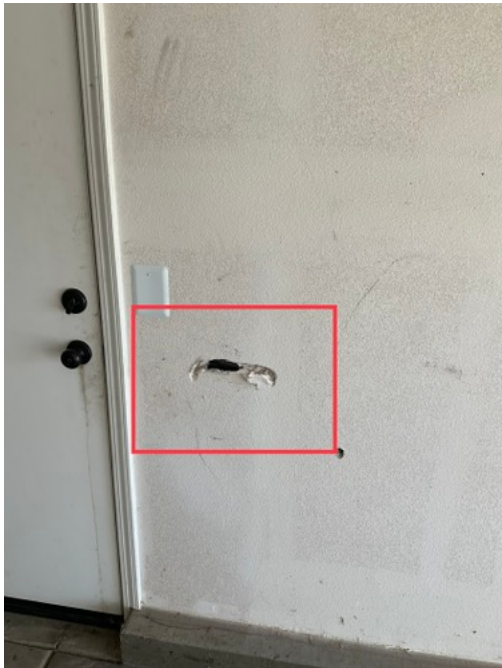
#### **11.3) Wall Conditions**

The interior walls had small holes. Recommend repairs as needed.

The interior walls had small holes. Recommend repairs as needed.
