Inspection Report

Kyle's Home Inspections

1234 Sample Ave Murrieta ca 92563

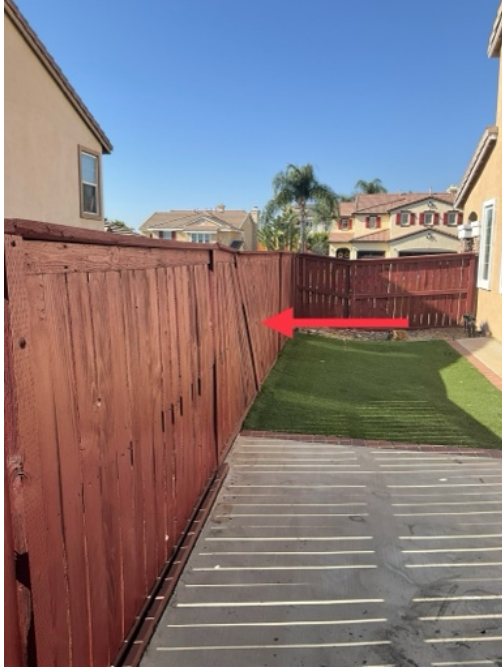
Backyard side fence was falling down. It is suggested that a "Licensed Fencing Contractor" be contacted for further evaluation and repair.

Backyard side fence was falling down. It is suggested that a "Licensed Fencing Contractor" be contacted for further evaluation and repair.

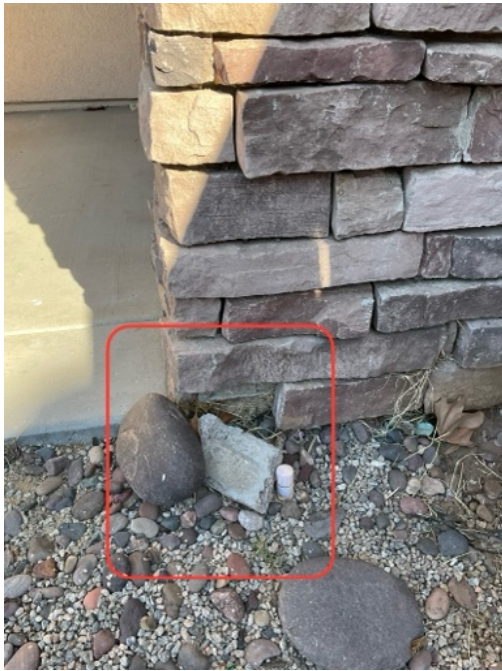
2.1) Front Entrance Conditions

Front rock features had a loose part. Recommend securing it back on.

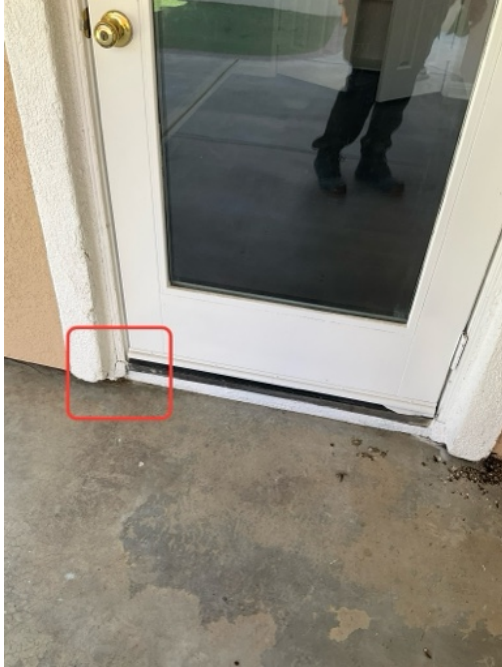
One small section near Backdoor had broken stucco. Recommend sealing as needed.

One small section near Backdoor had broken stucco. Recommend sealing as needed.

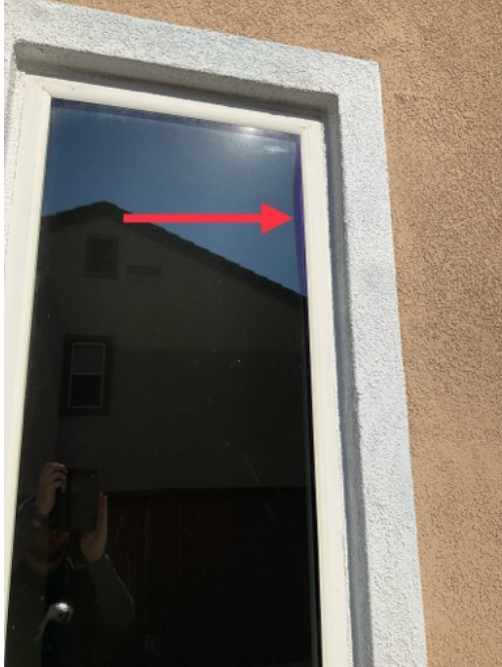
The seals inside the window panes are popping out on multiple windows. Backyard 2nd floor window has broken window trim. It is suggested that a "Licensed window Contractor" be contacted for further evaluation and repair.

The seals inside the window panes are popping out on multiple windows. Backyard 2nd floor window has broken window trim. It is suggested that a "Licensed window Contractor" be contacted for further evaluation and repair.

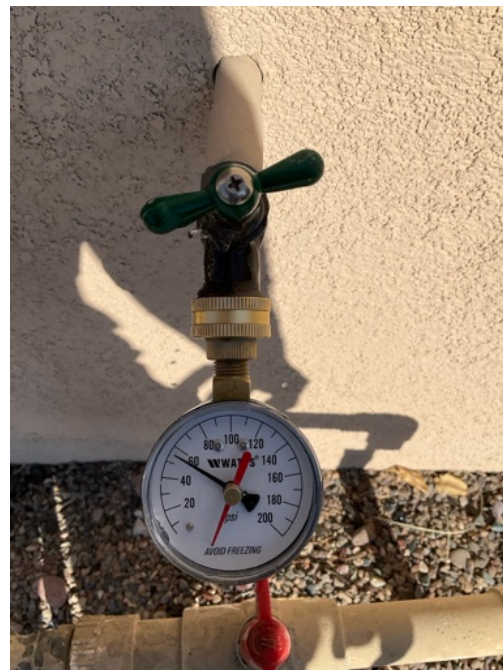
2.6) Faucet Conditions

Front & backyard faucet handle leaked. It is suggested that a "Licensed Plumbing Contractor" be contacted for further evaluation and repair.

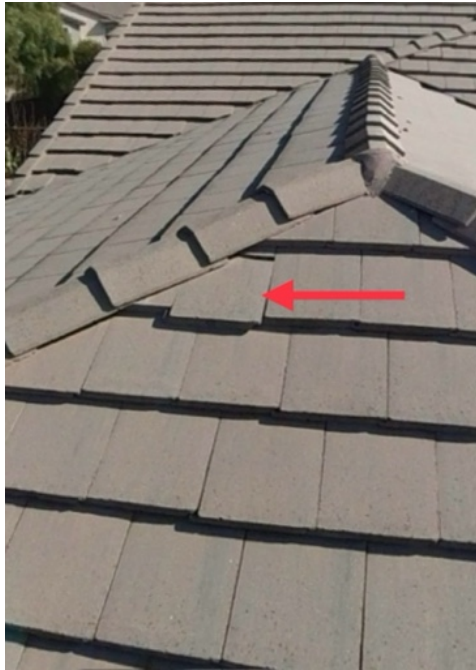
One slipped tile in front of home above garage.

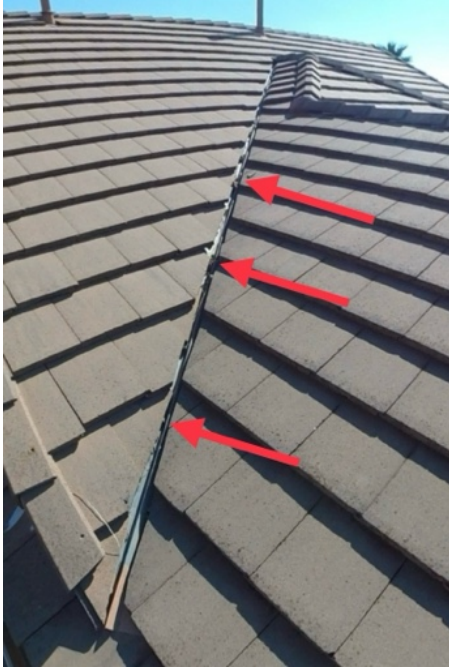
3.2) Flashing Conditions

Valleys in front of home had debris inside them. Recommend cleaning.

Valleys in front of home had debris inside them. Recommend cleaning.

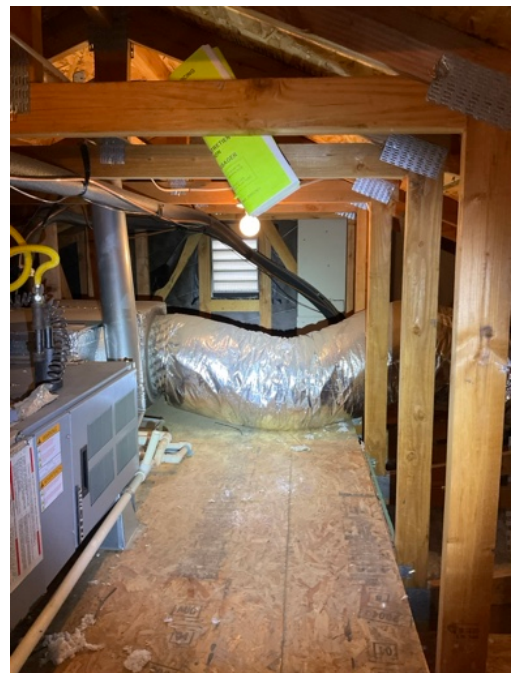
3.4) Attic Conditions

2x4 was cut and damaged near entrance. One exhaust fan is slipping out and needs to be secured better to vent.

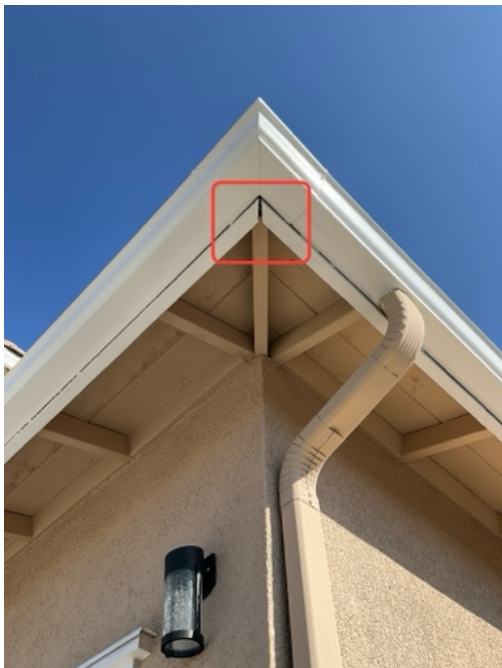
3.7) Conditions

Front of home had gaps in the fascia boards on the corners. Splits in eaves. Recommend repairs as needed. It is suggested that a "Licensed Roofing Contractor" be contacted for further evaluation and repair.

Front of home had gaps in the fascia boards on the corners. Splits in eaves. Recommend repairs as needed. It is suggested that a "Licensed Roofing Contractor" be contacted for further evaluation and repair.

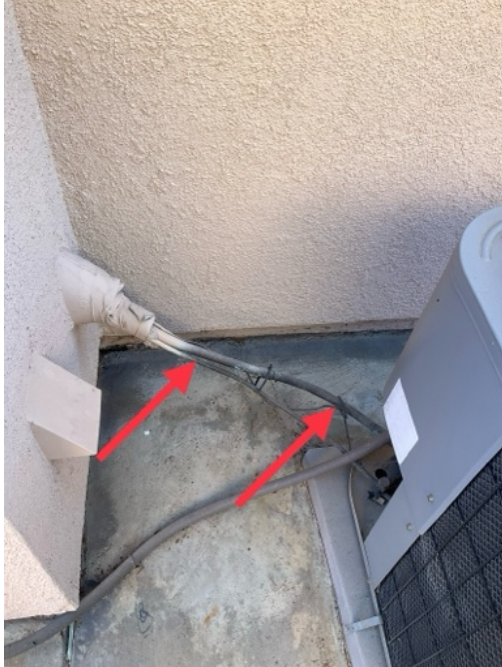
The insulation on the refrigerant lines was missing or deteriorated. Recommend installing this rather inexpensive pipe insulation to improve efficiency. Pipe insulation is available at most hardware stores. Units are 20 years old and nearing the end of their lifespan.

The insulation on the refrigerant lines was missing or deteriorated. Recommend installing this rather inexpensive pipe insulation to improve efficiency. Pipe insulation is available at most hardware stores. Units are 20 years old and nearing the end of their lifespan.

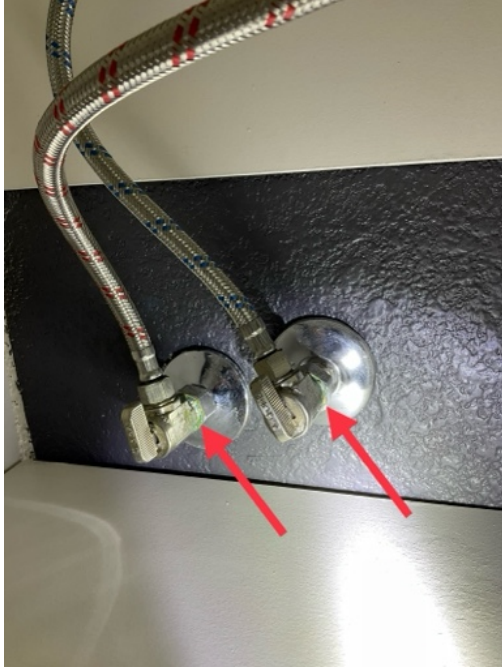
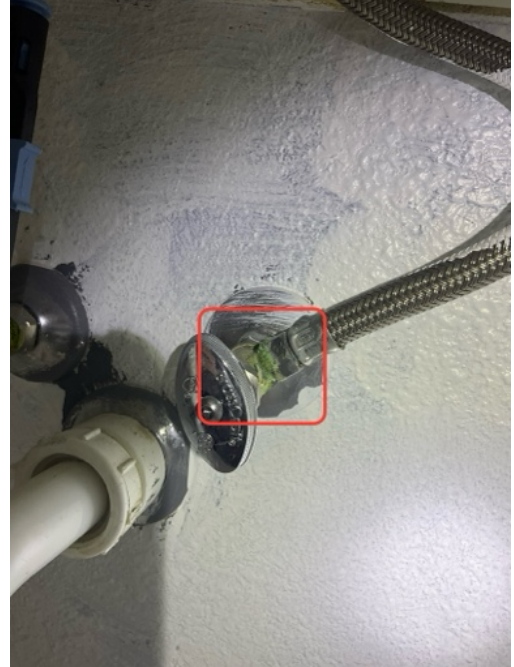
6.2) Supply Line Conditions

The visible portions of the supply lines had minor corrosion observed at the accessible areas.

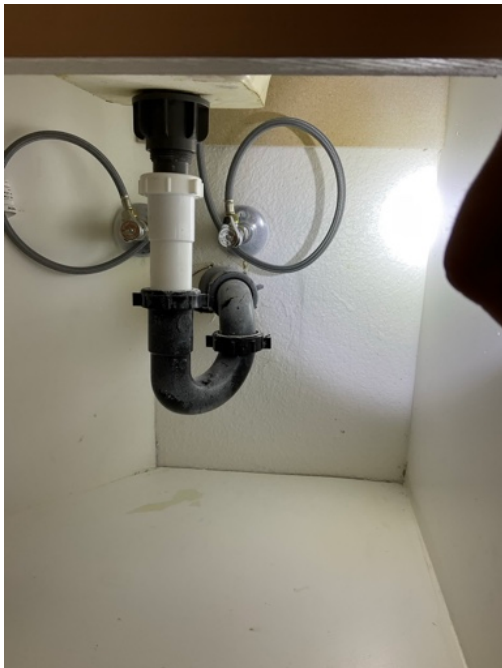
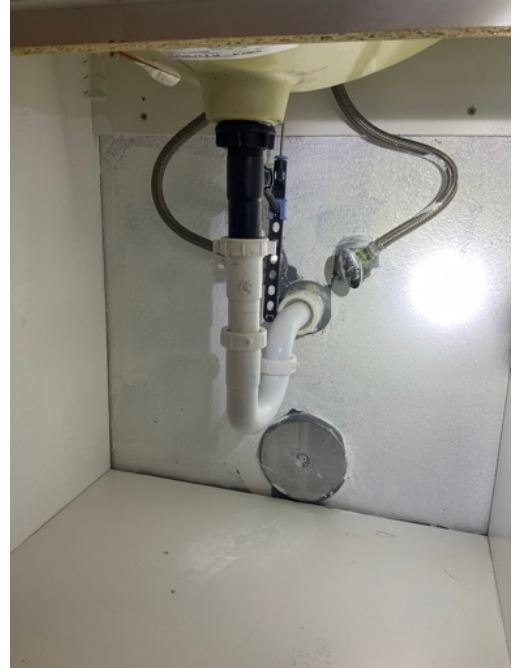
6.3) Drain Line Conditions

Upstairs master bath had flex plumbing. Recommended replacing with proper plumbing.

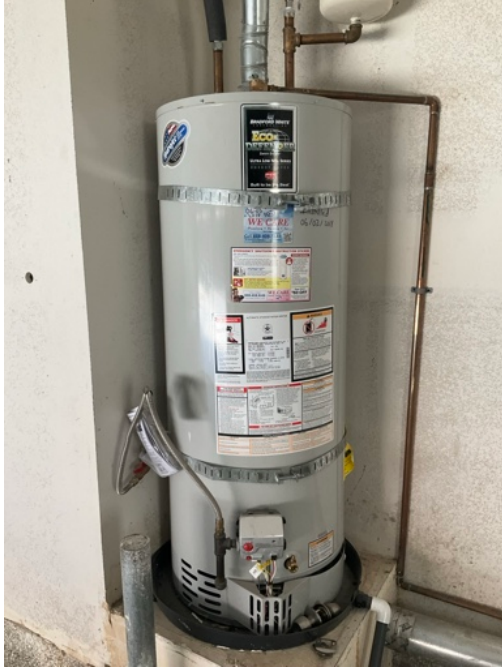
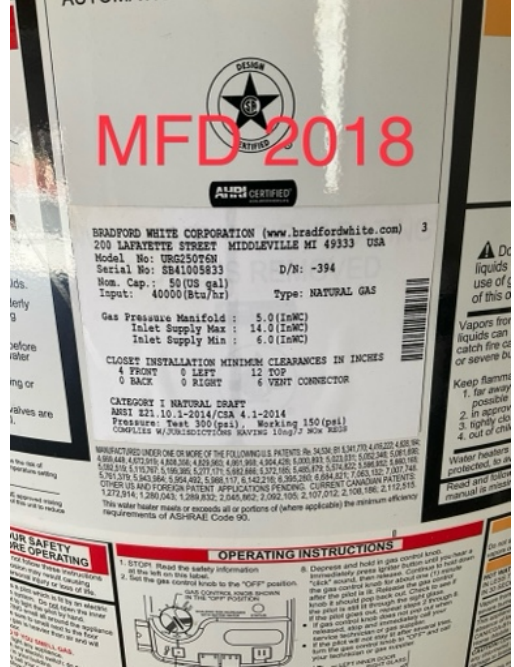
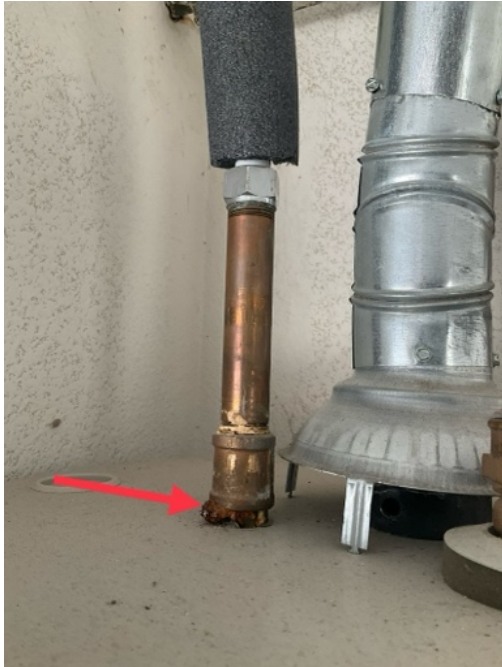
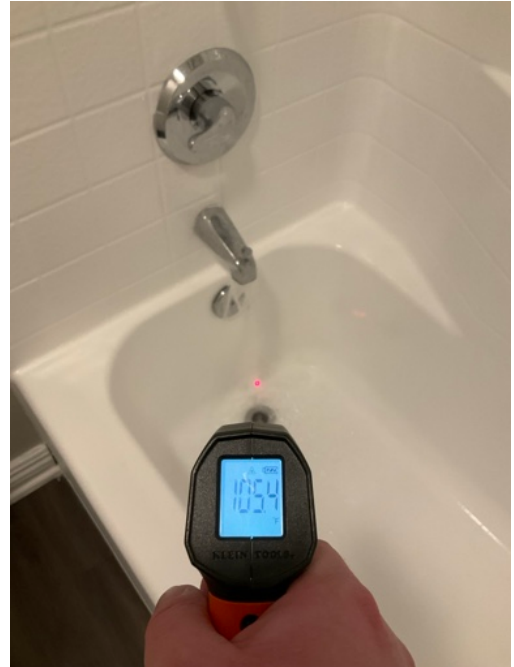
6.4) Water Heater Conditions R

Minor corrosion on water line. It is suggested that a "Licensed Plumbing Contractor" be contacted for further evaluation and repair.

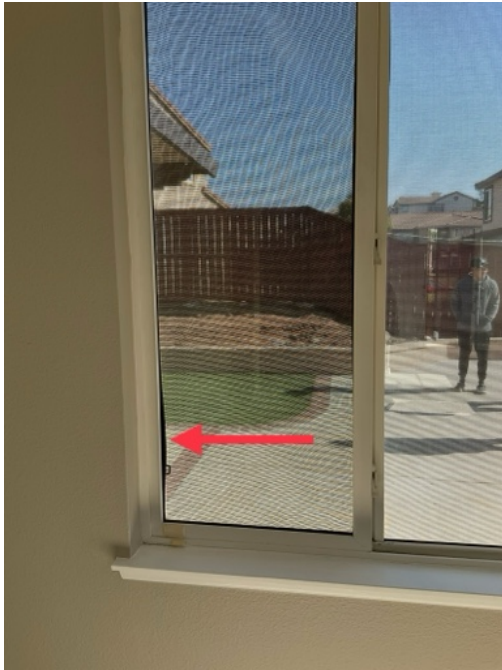
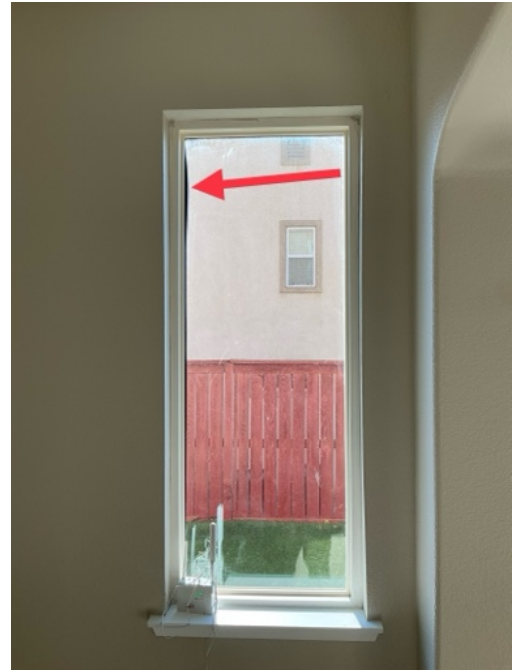
7.5) Interior Window Conditions

2 windows has seals inside that coming out. It is suggested that a "Licensed window Contractor" be contacted for further evaluation and repair.

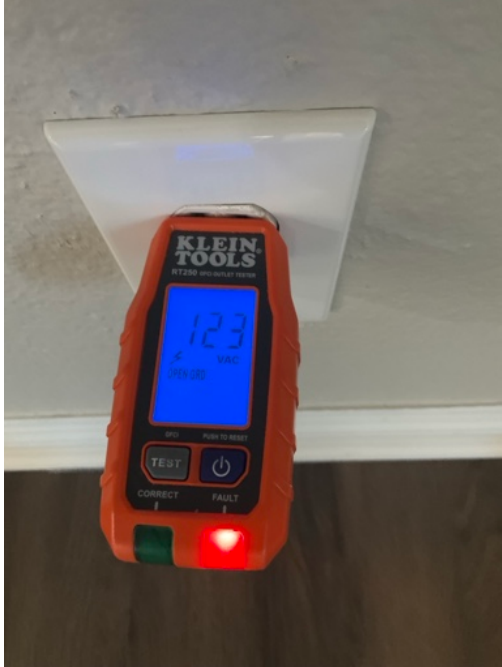
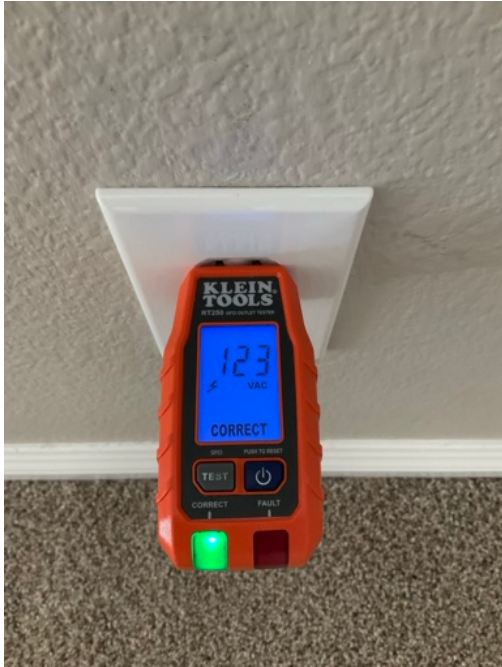
7.7) Electrical Conditions

Open ground outlet near fire place. It is suggested that a "Licensed Electrical Contractor" be contacted for further evaluation and repair.

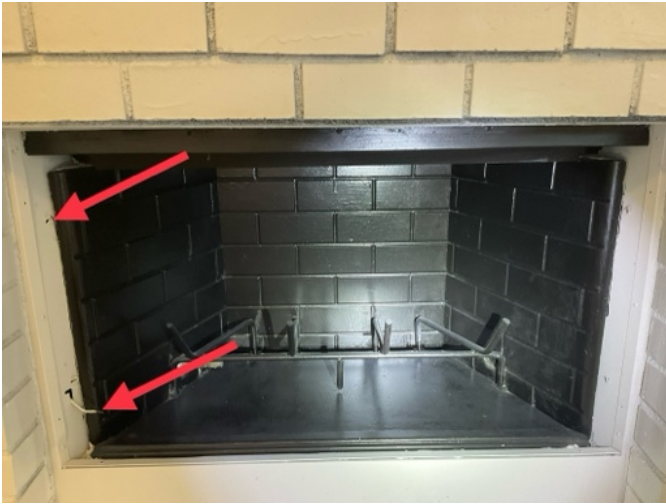
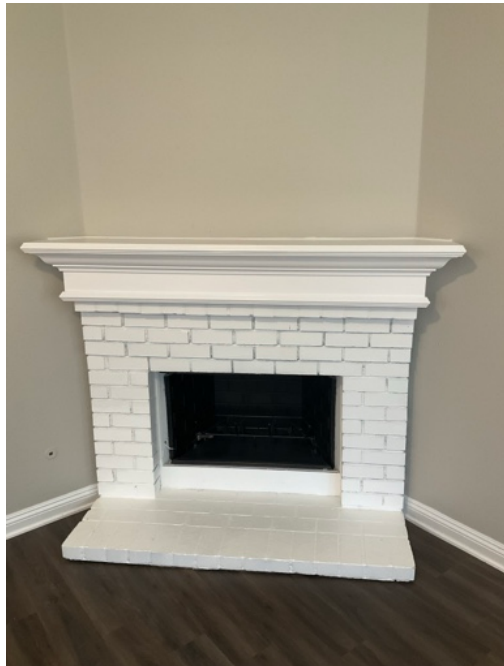
7.10) Fireplace Conditions

Missing doors to fireplace and damper latch. It is suggested that a "Licensed chimney Contractor" be contacted for further evaluation and repair.

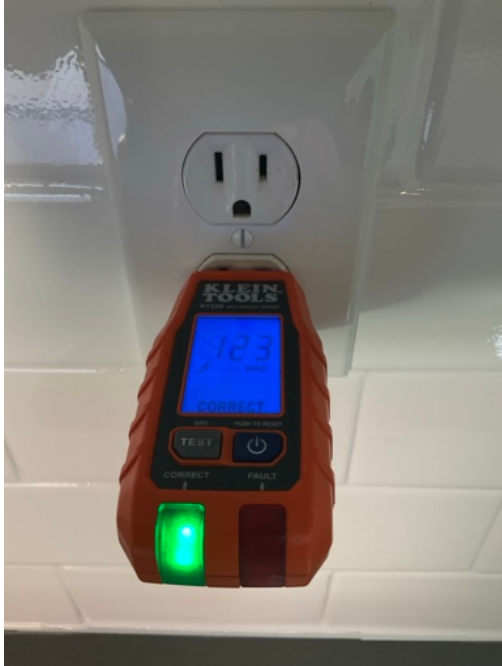
8.7) Electrical Conditions

Kitchen island was off.

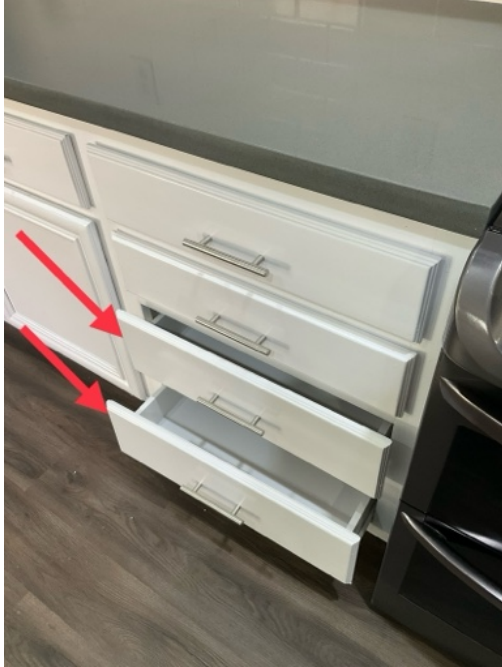
8.10) Cabinet Conditions

The cabinets were loose. Recommend securing or repair as needed for increased safety. One cabinet was stuck and would not operate.

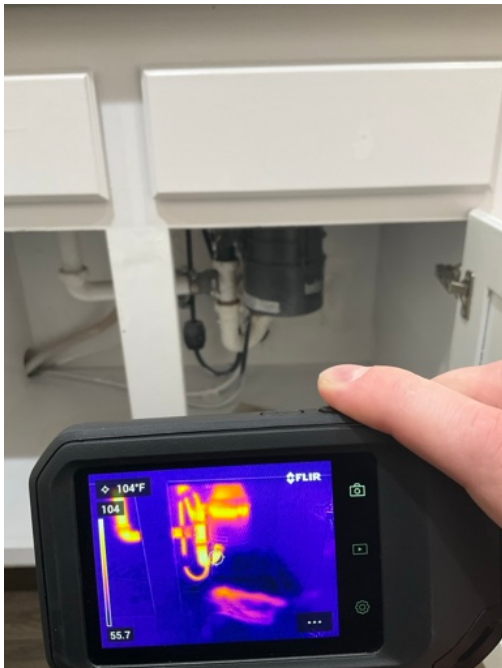
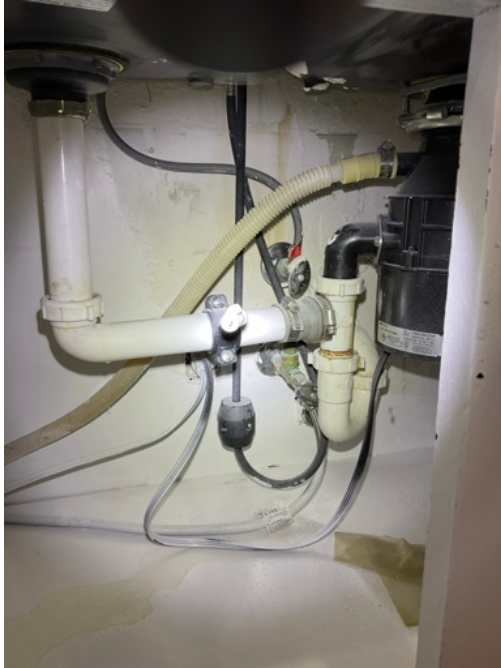
8.11) Sink Plumbing Conditions

Kitchen sink was leaking and water was running down the cords and Into the reciprocal underneath the sink. Unplugged dishwasher and garbage disposal. It is suggested that a "Licensed Plumbing Contractor" be contacted for further evaluation and repair.

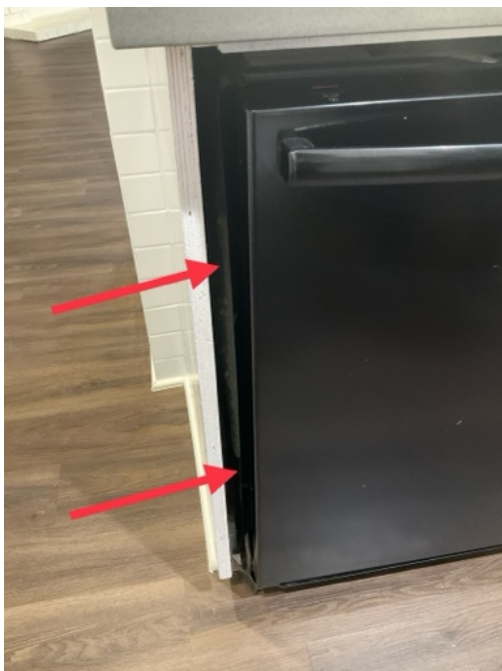
8.15) Dishwasher Conditions

Not inspected due to power being off at kitchen island. Dishwasher was not secured in place either.

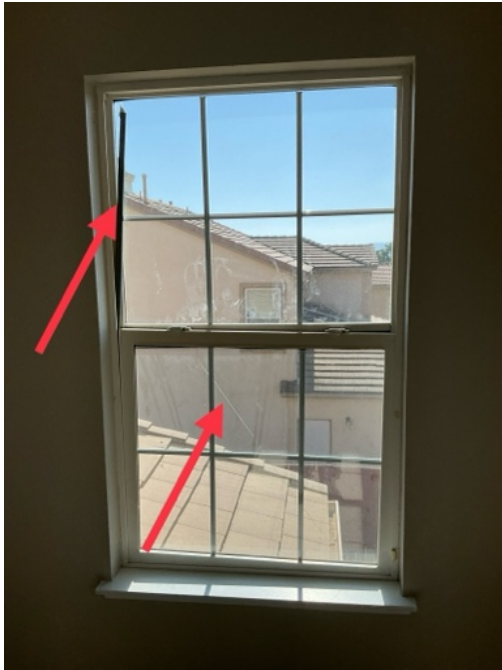
Windows - Doors**9.5) Interior Window Conditions**

Cracked glass pane(s) were observed at upstairs. Window mechanism is sticking out and doesn't function. Recommend repair as needed.

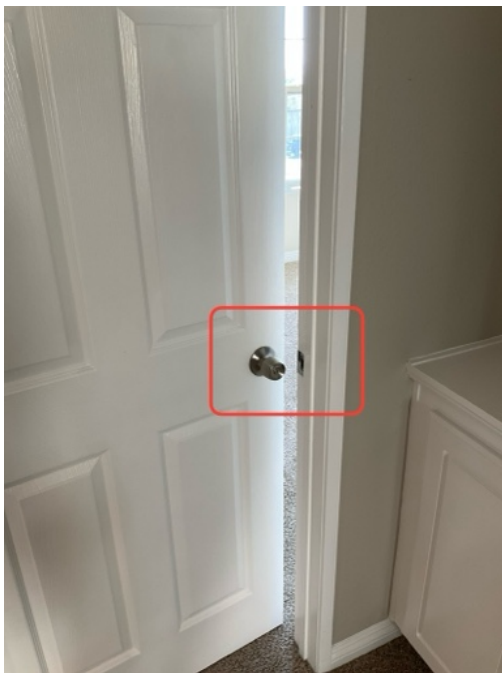
9.6) Interior Door Conditions

Upstairs bedroom door doesn't latch properly. It is suggested that a "Certified Handy Man" be contacted for further evaluation and repair.

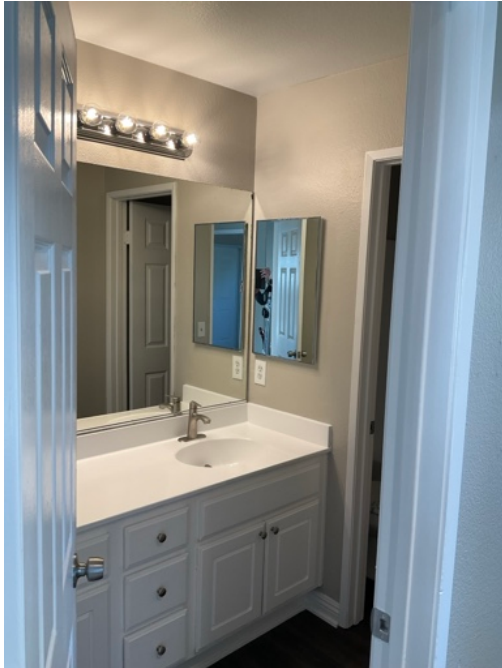
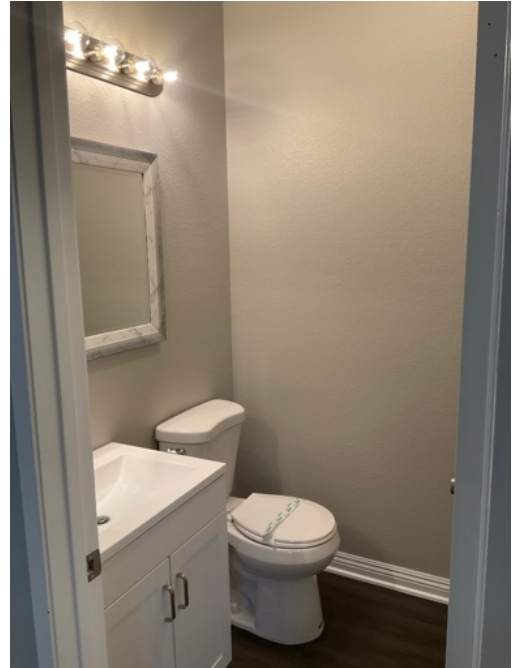
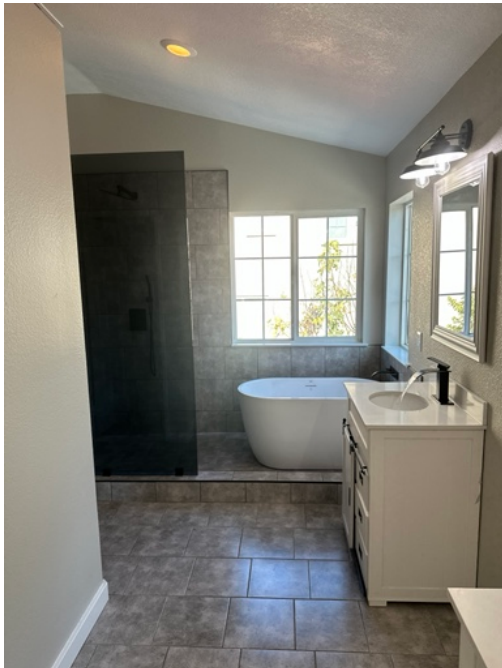
10.1) Wall Conditions

The general condition of the walls appeared to be in serviceable condition at the time of the inspection.

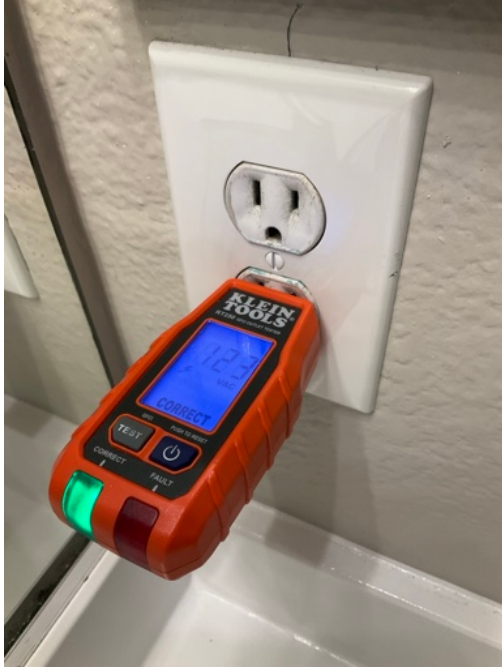
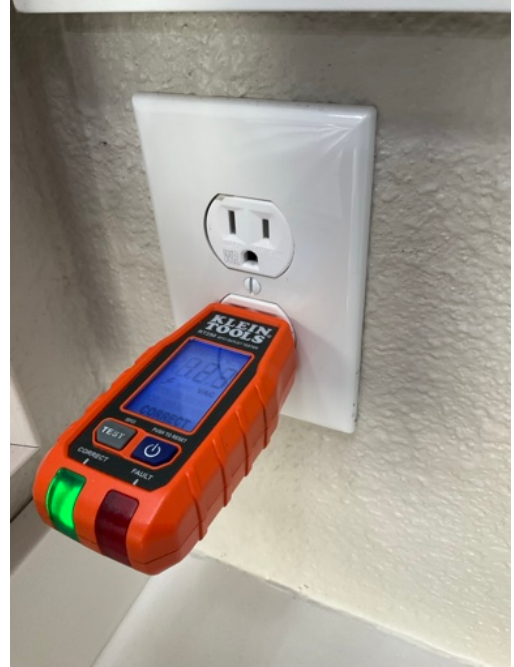
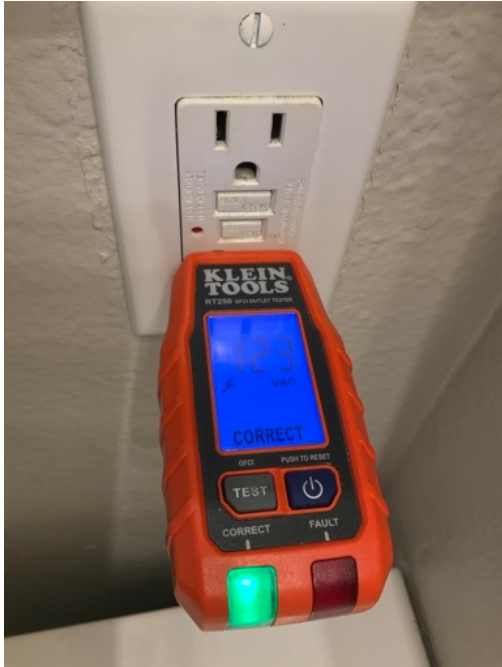
Electrical Conditions**10.7) Electrical Conditions**

Appears Serviceable.

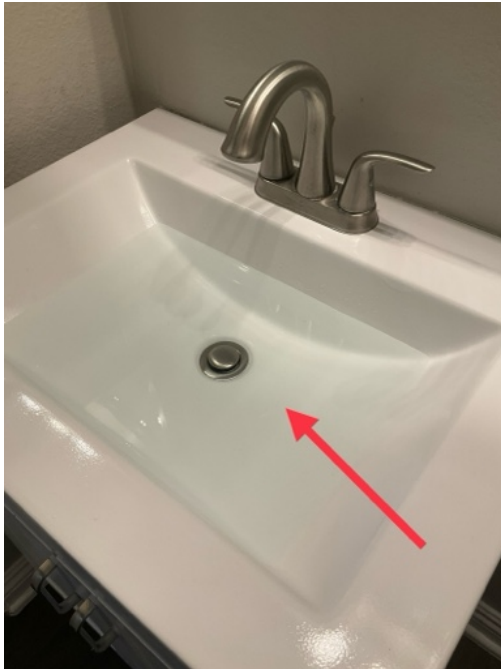
10.11) Sink Conditions

Downstairs restroom had a slow drain.

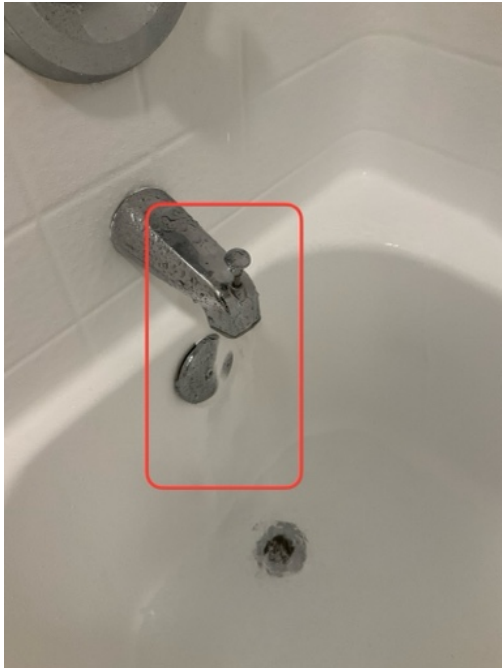
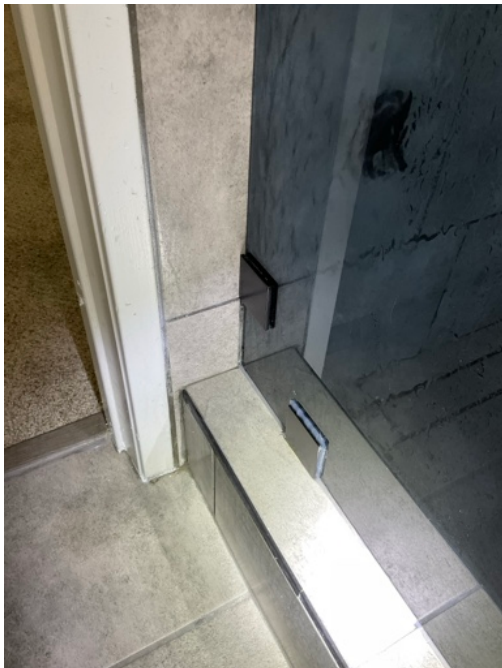
**Shower - Tub - Toilet****10.12) Shower - Tub Conditions**

Upstairs guest shower tub diverter was leaking and not functioning properly. Upstairs master stand up shower had a leak on the windows and should be sealed. It is suggested that a "Licensed Plumbing Contractor" be contacted for further evaluation and repair.

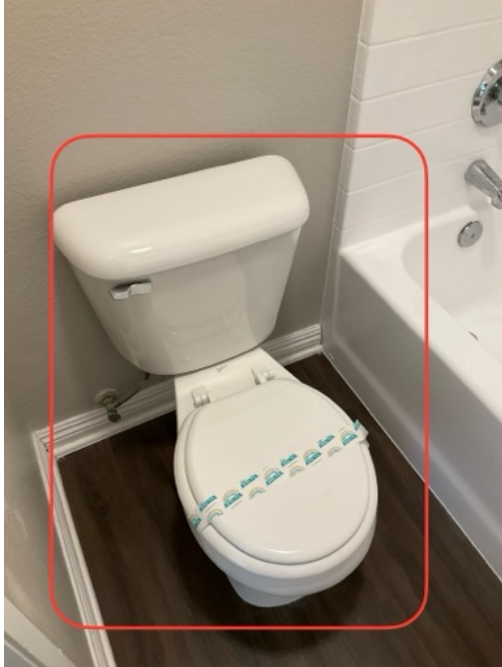
10.13) Toilet Conditions

Upstairs guest bathrooms toilet continuously runs. It is suggested that a "Licensed Plumbing Contractor" be contacted for further evaluation and repair.

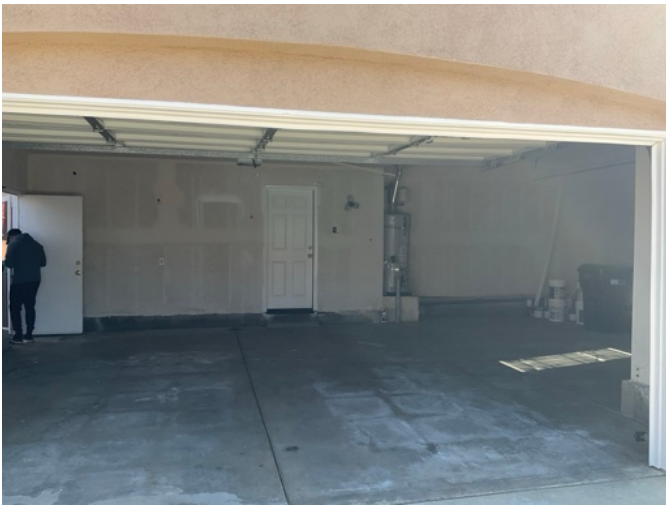
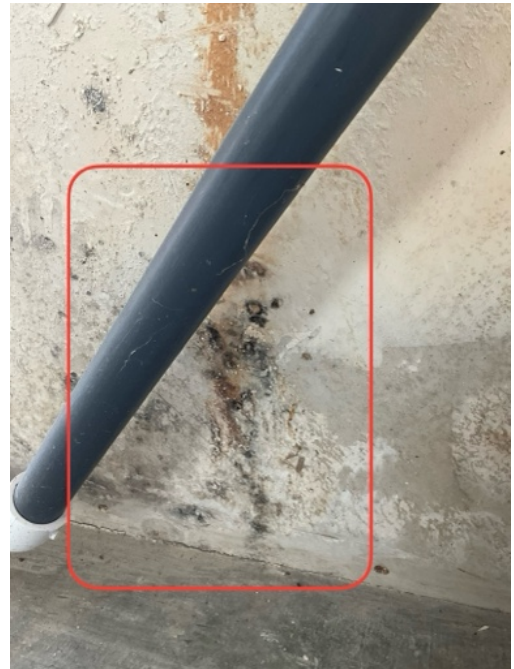
11.1) Wall Conditions

Suspicious growth near water heater.

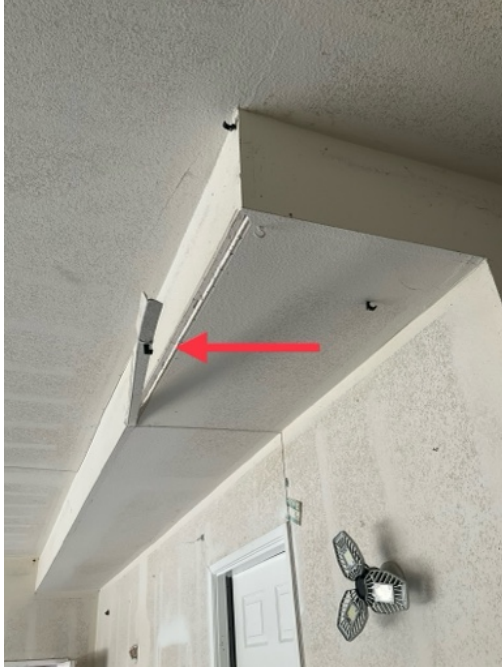
11.2) Ceiling Conditions

Some of the drywall edge is coming off as well as a suspicious spot in between the garage doors on the ceiling.

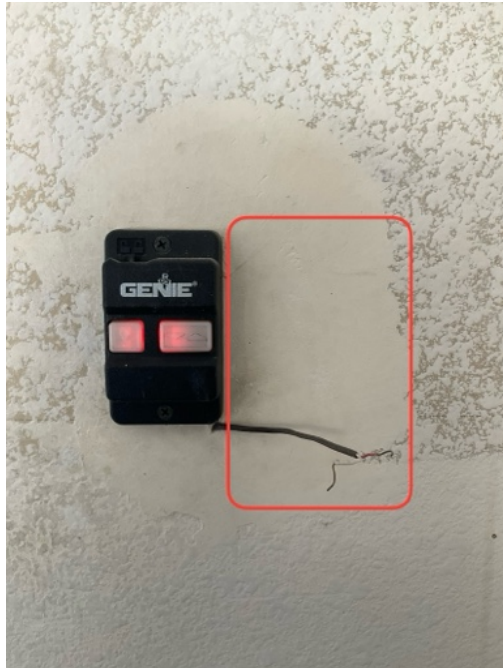
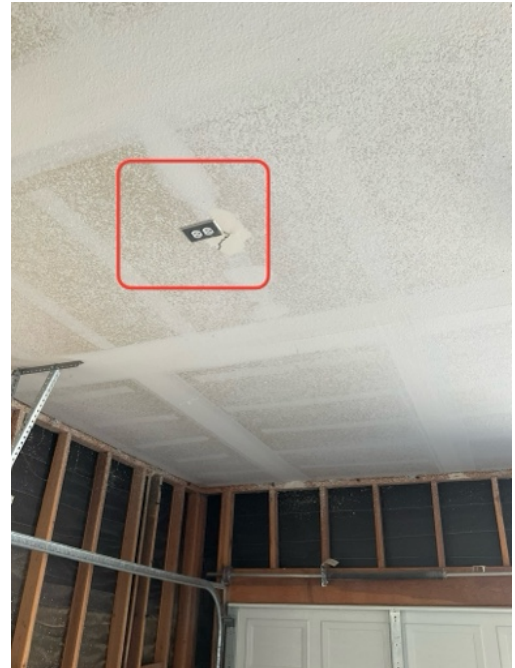
11.5) Vehicle Door Conditions

No motor for single garage door.

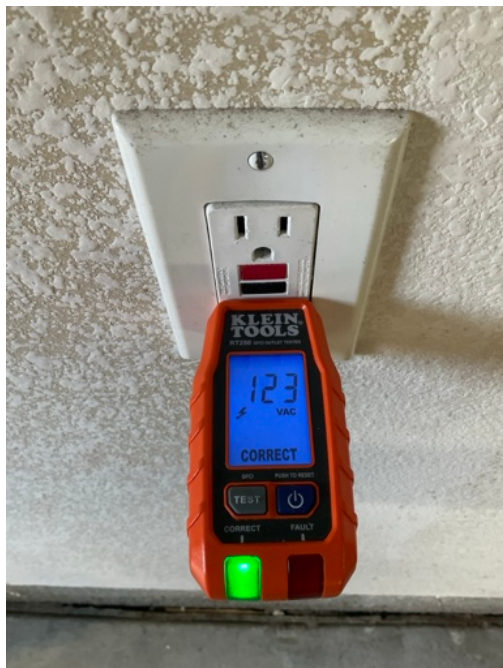
11.6) Electrical Conditions

Appears Serviceable.

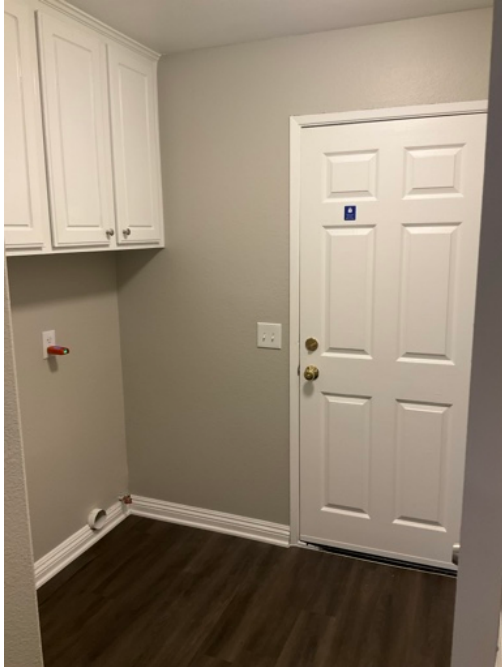
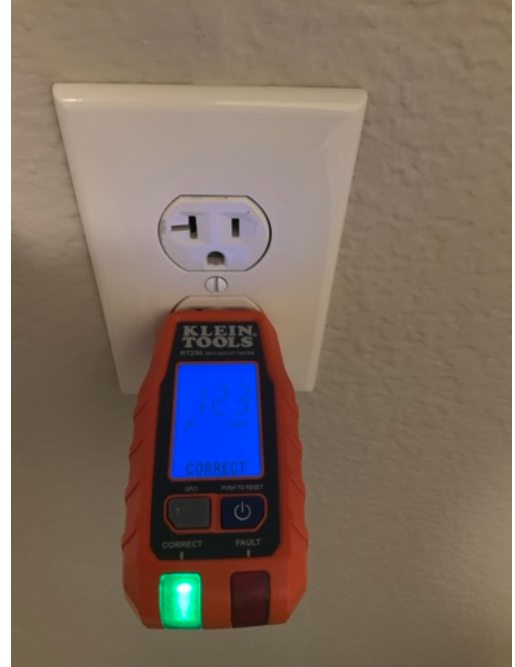
11.8) Laundry Room Conditions

There were no appliances present for proper testing of plumbing components.

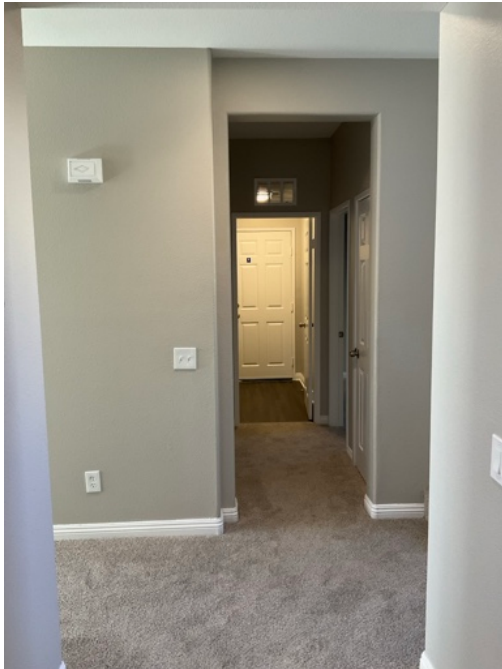
13.1) Conditions

Appears Serviceable.

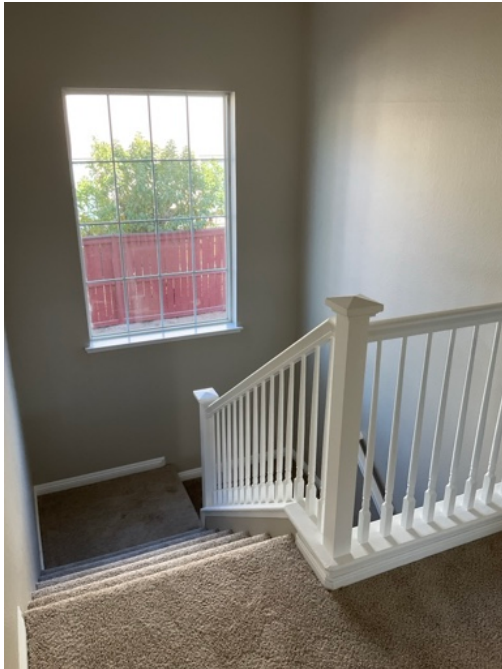
14.1) Conditions

Appears Serviceable.
